**Phase 1 Cranford Historic Resources Survey:
Review of Existing Documentation, Baseline Inventory, and Survey Updates**

Cranford Historic Preservation Advisory Board
Cranford Township, NJ
November 2016

Volume 1: Phase 1 Report

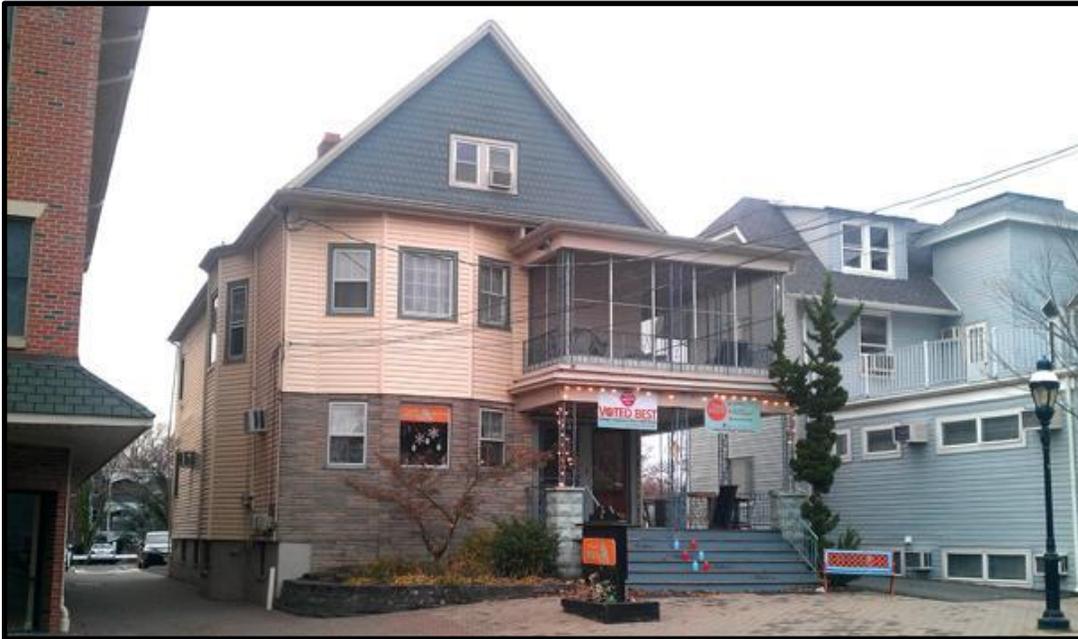
2) 35 Alden Street (Block 189, Lot 14)

The building has been extensively altered over time, and does not appear to have any significant historic associations. The building does not appear to meet the criteria for individual eligibility and is not located in any existing or potential historic district; No further research or documentation recommended.

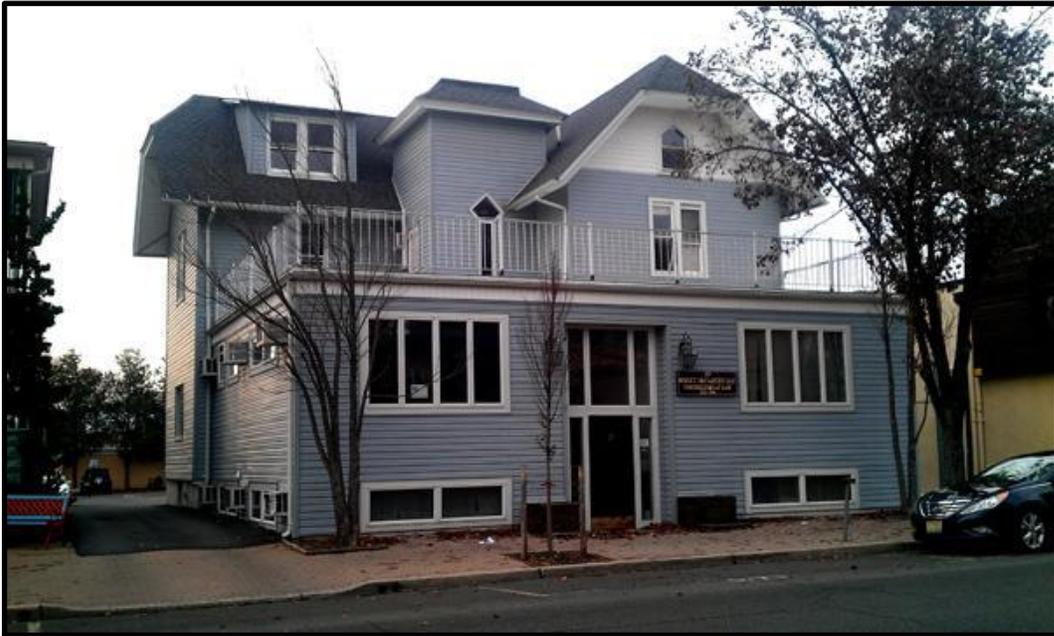
3) 37 Alden Street (Block 189, Lot 13)

The building has been extensively altered over time, and does not to have any significant historic associations. The building does not appear to meet the criteria for individual eligibility and is not located in any existing or potential historic district; No further research or documentation recommended.

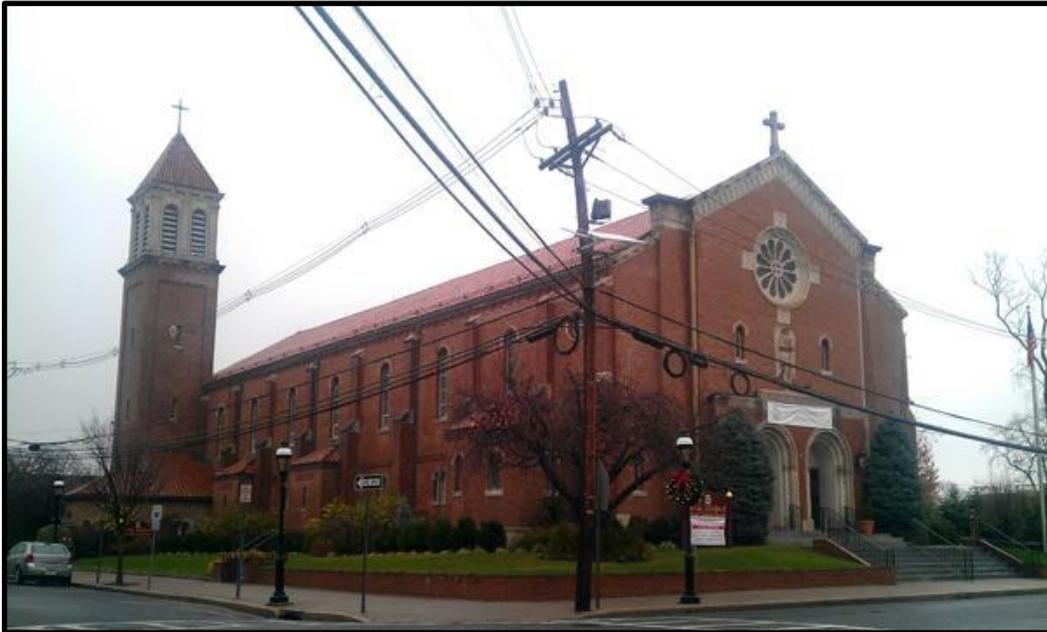
4) St. Michaels Roman Catholic Church, 40 Alden Street (Block 191, Lot 1)

This church is the third structure occupied by St. Michaels parish (the second on this site), and represents the continued growth of the Catholic community in Cranford in the post-war period. The church is a well preserved example of mid-century Romanesque Revival architecture and is eligible as a complex with St. Michaels School and the Catholic Community Services building.

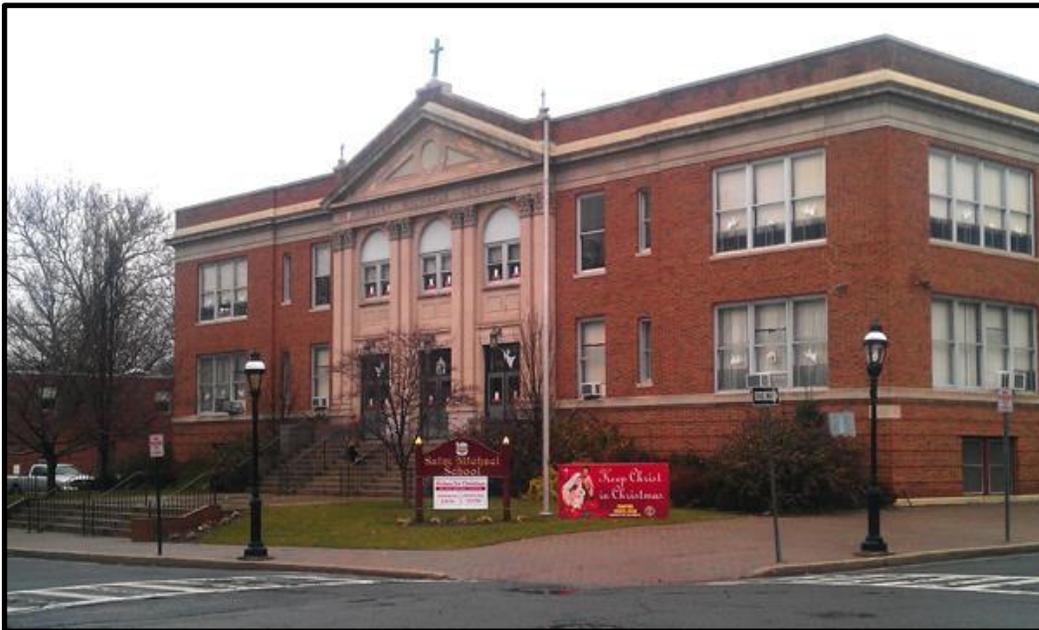
5) St. Michaels School, 100 Alden Street (Block 188, Lot 1)

St. Michaels School is a well preserved Classical Revival institutional building, and is eligible as a complex with St. Michaels Church and the Catholic Community Services building. The building is also eligible as a contributing building within the recommended expanded boundary of the eligible North Cranford Historic District.

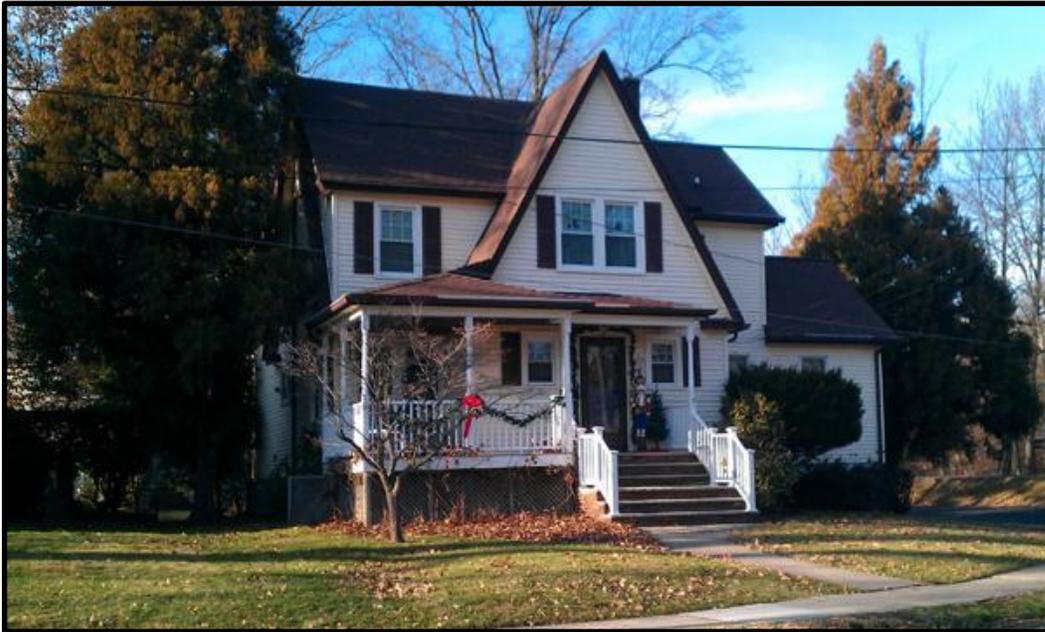
6) 18 Balmiere Parkway (Block 199, Lot 11)

18 Balmiere Parkway stands within the eligible North Cranford Historic District. The house has been altered, but additional research at Phase 2 will be needed to determine architectural integrity and status within the historic district.

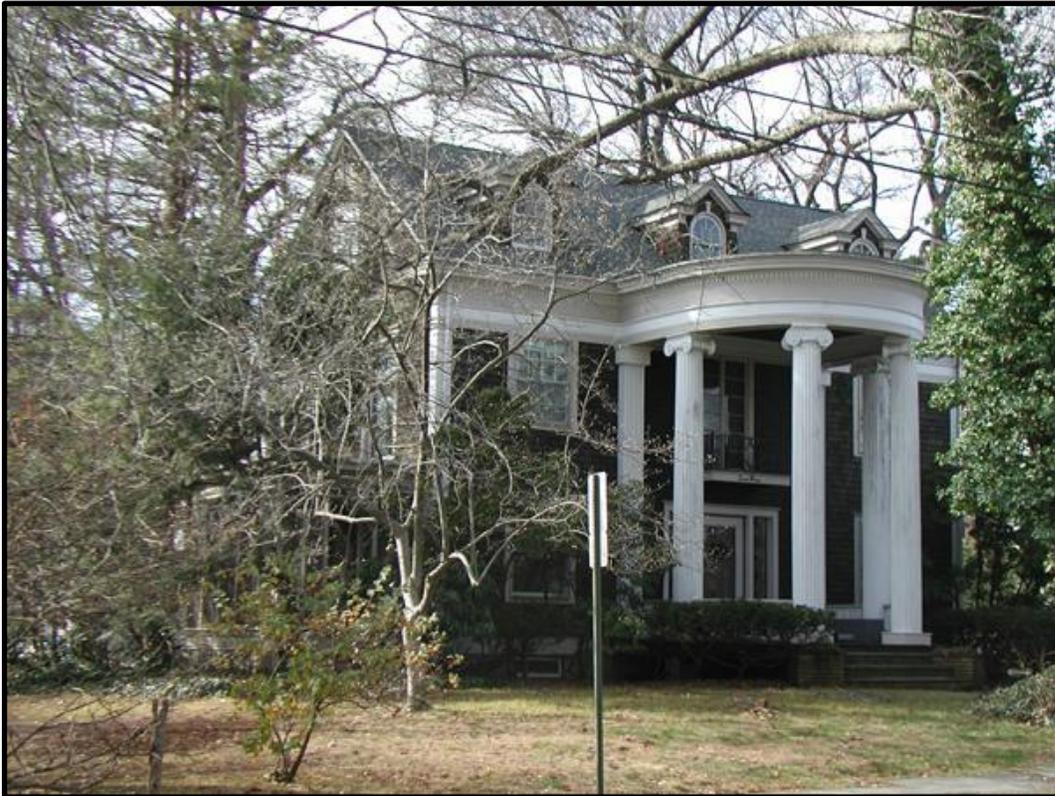
11) 17 Berkeley Place (Block 166, Lot 5)

17 Berkeley place is a well preserved example of Neo-Classical style residential architecture and is eligible for the National Register under Criterion C at a local level of significance. This property is also eligible as a key-contributing building within the eligible North Cranford Historic District.

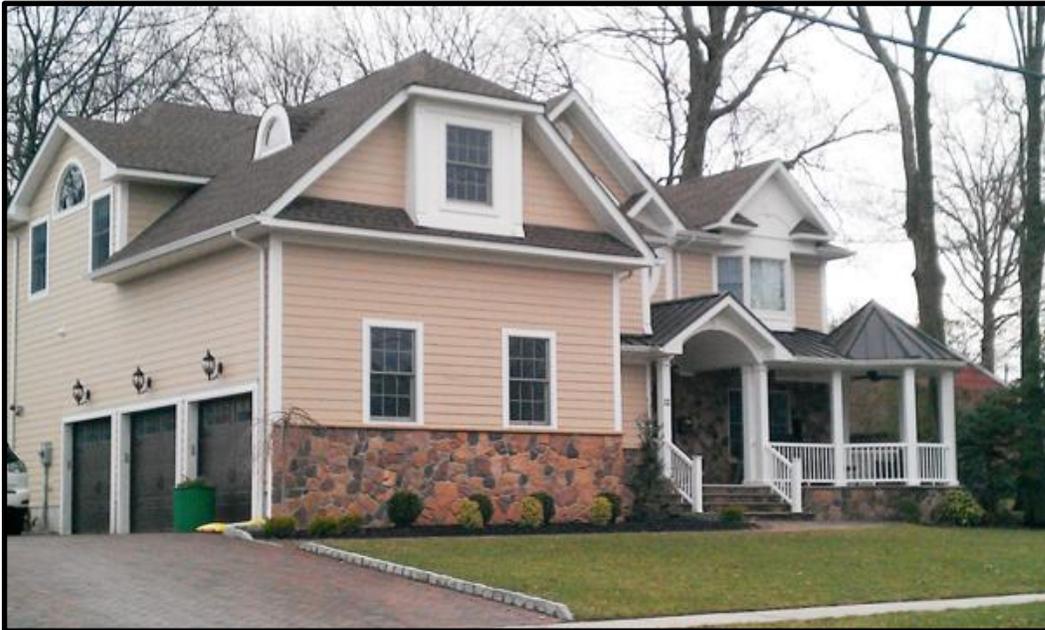
12) 12 Bloomingdale Avenue (Block 304, Lot 4)

12 Bloomingdale Avenue was demolished and replaced with this modern house in 2012. Not eligible. No further research or documentation recommended.

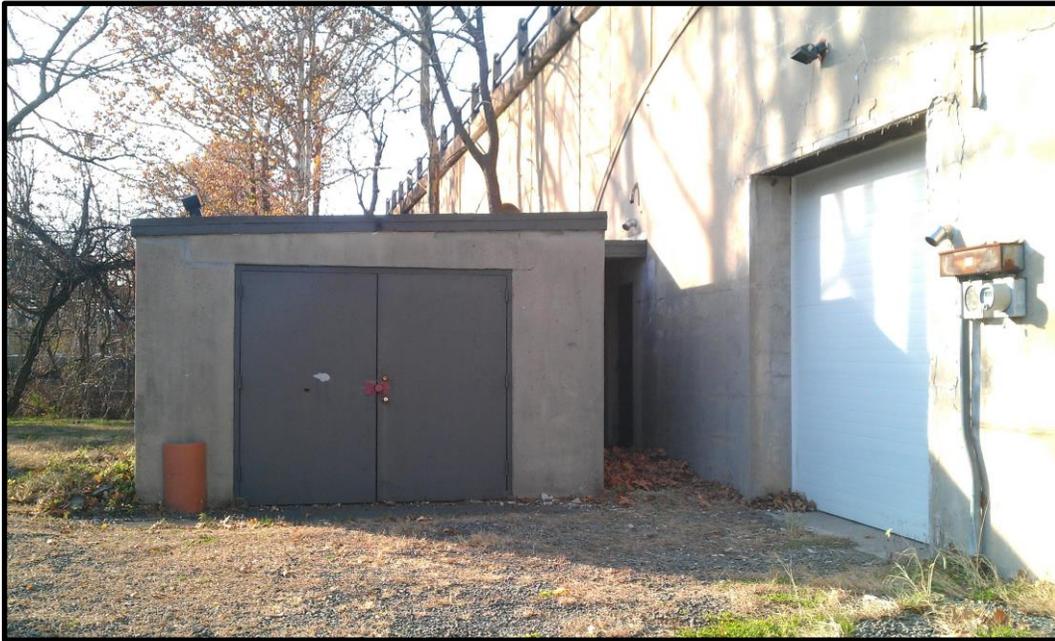
14) Storage Building, Centennial Avenue (Block 479, Lot 3)

This building does not appear to be 50 years old and does not possess any architectural character or significance. Not eligible. No further research or documentation recommended.

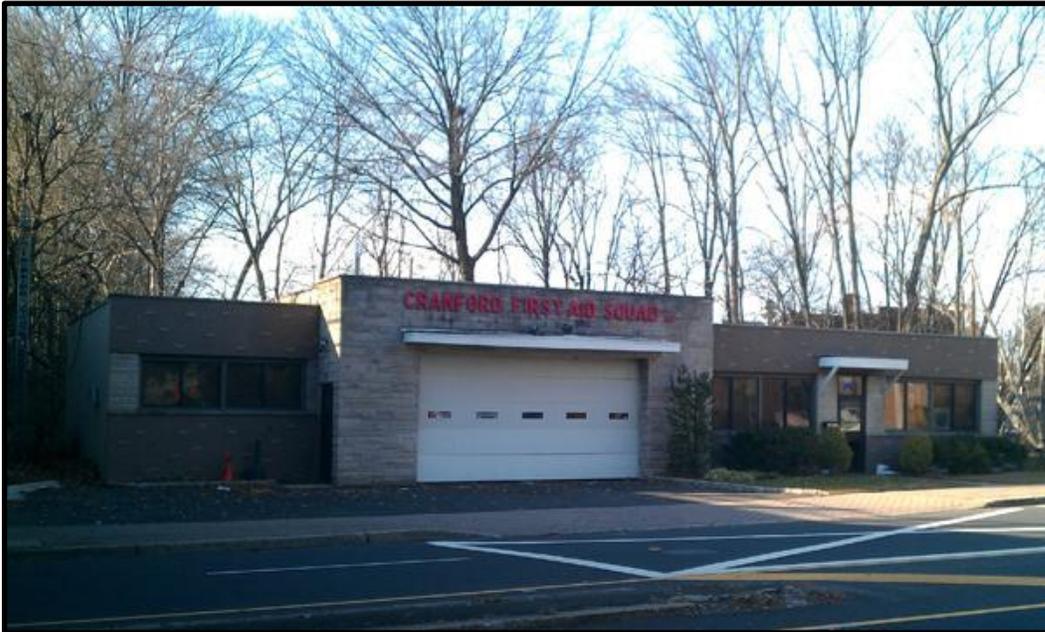
16) Cranford First Aid Squad, 6 Centennial Avenue (Block 313, Lot 1)

This building was constructed by the First Aid Squad, which was organized in 1953. It is an interesting but simple representation of modern architecture in Cranford, of which there are relatively few examples, but has been altered through window replacement and interior rehabilitation. Not eligible. No further research or documentation recommended.

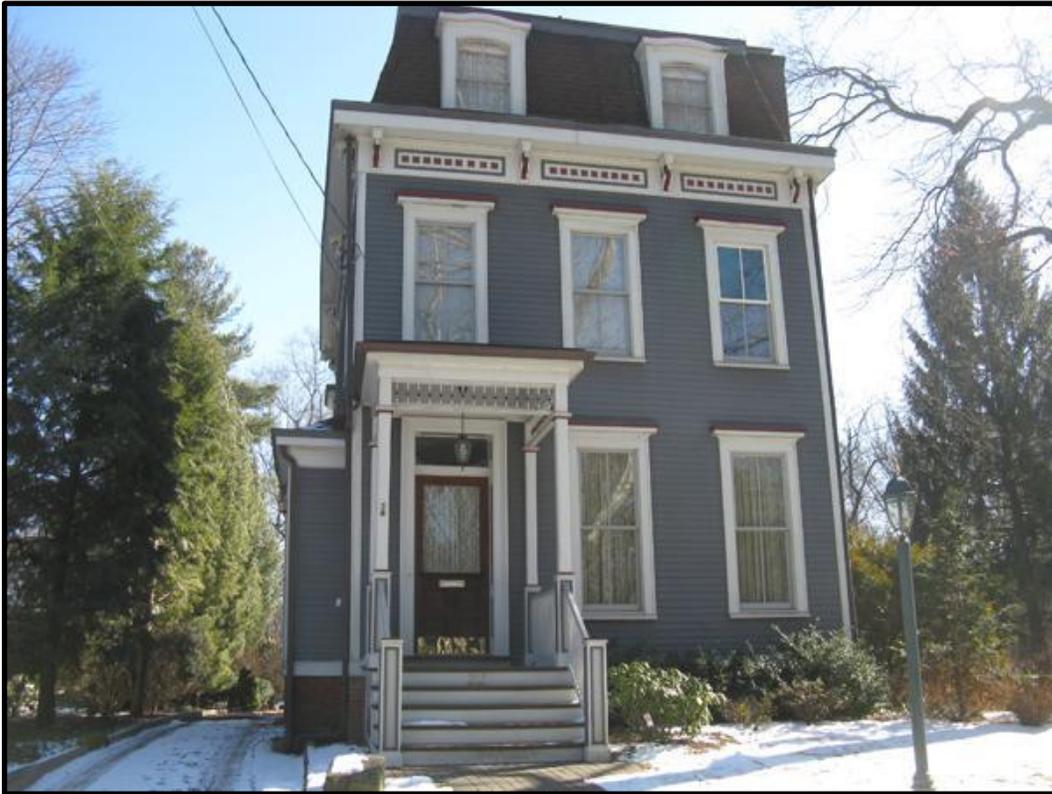
17) Moore House, 22 Central Avenue (Block 184, Lot 12)

The Moore House is a well preserved example of Second Empire style residential architecture and is eligible for the National Register under Criterion C at a local level of significance. This property is also eligible as a key-contributing building within the eligible North Cranford Historic District.

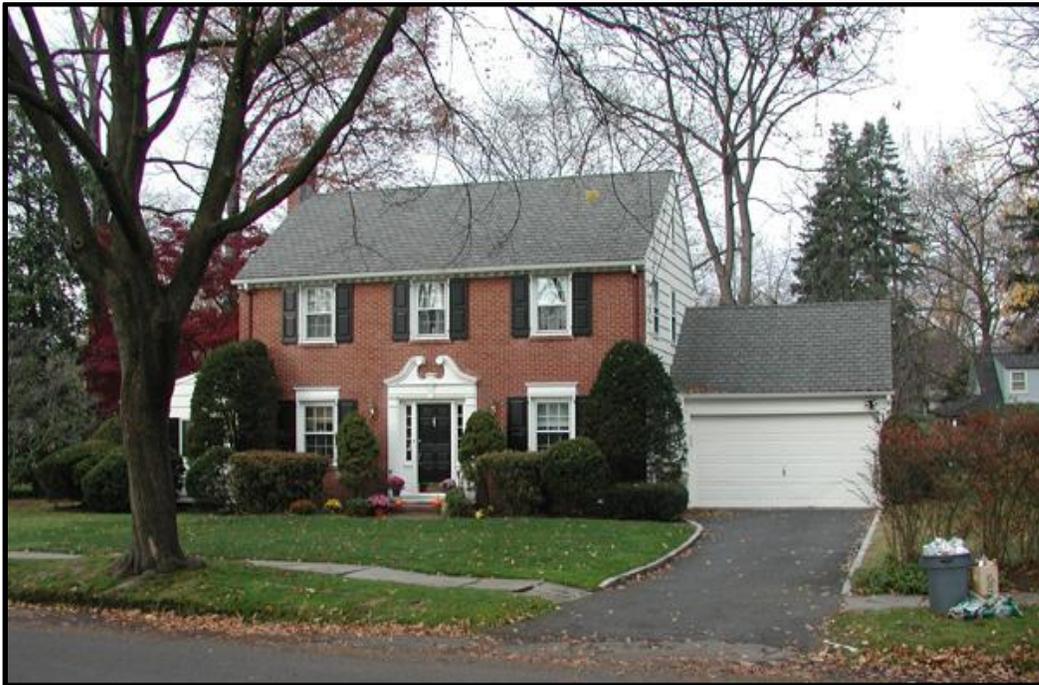
19) 201 Central Avenue (Block 223, Lot 6)

201 Central Avenue is eligible as a contributing building within the eligible North Cranford Historic District.

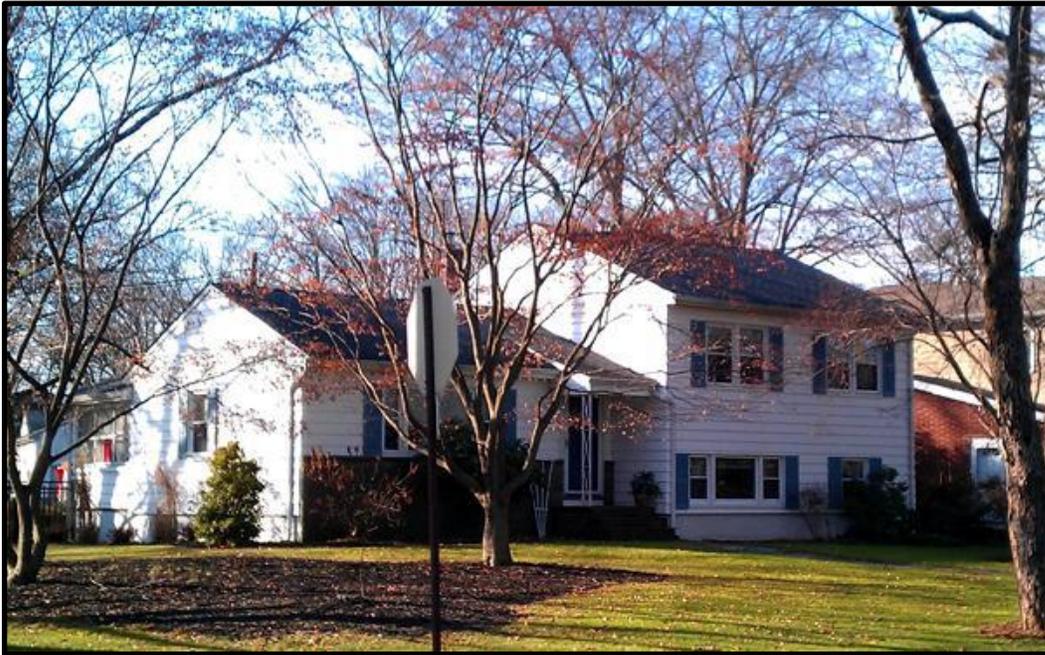
22) 101 County Park Drive (Block 106, Lot 12)

Although recommended as eligible in the 1984 survey, the house has since been altered; bargeboard, shutters, Doric porch columns, and porch railings have all been removed. The house has lost architectural integrity, and does not appear to have any significant historic associations. The building does not appear to meet the criteria for individual eligibility and is not located in any existing or potential historic district; No further research or documentation recommended.

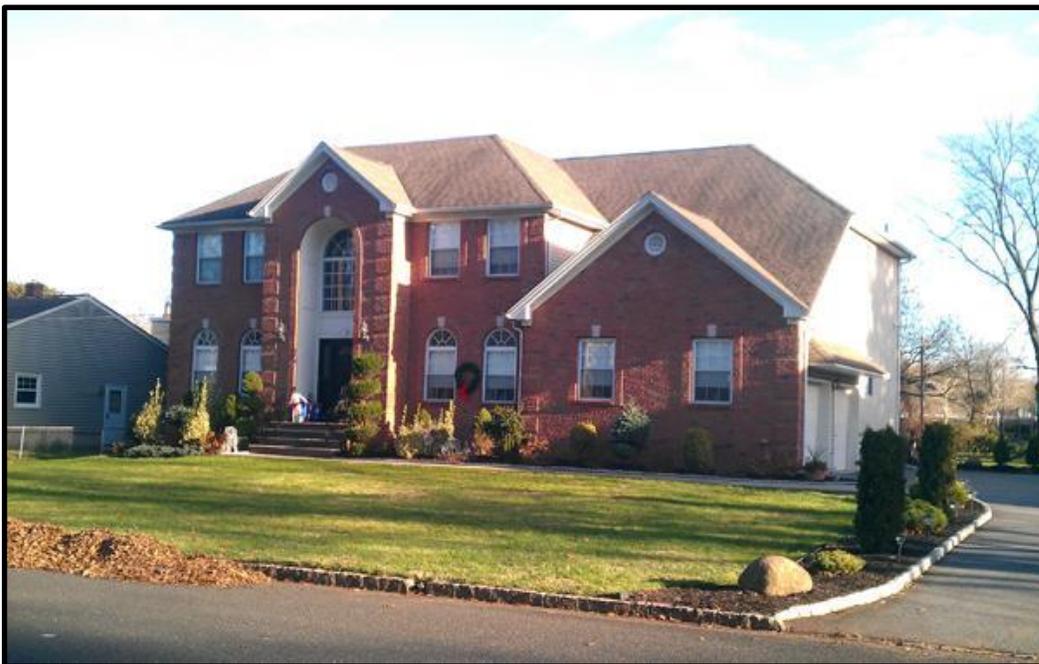
26) 160 Denman Road (Block 489, Lot 1)

160 Denman Road was demolished and replaced with this modern house c2001. Not eligible.
No further research or documentation recommended.

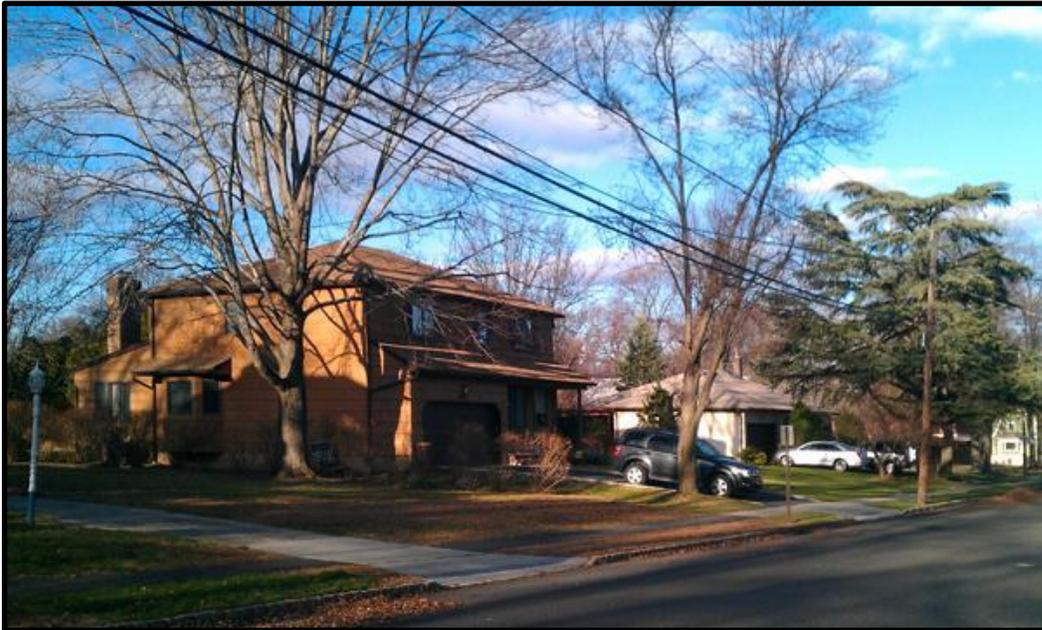
27) Denman Farm (Ditzel's Farm), 299 Denman Road

The Denman Farm farmhouse, which stood near this residence at 301 Denman Road, was demolished and developed with modern houses in the early 1980's. Not eligible. No further research or documentation recommended.

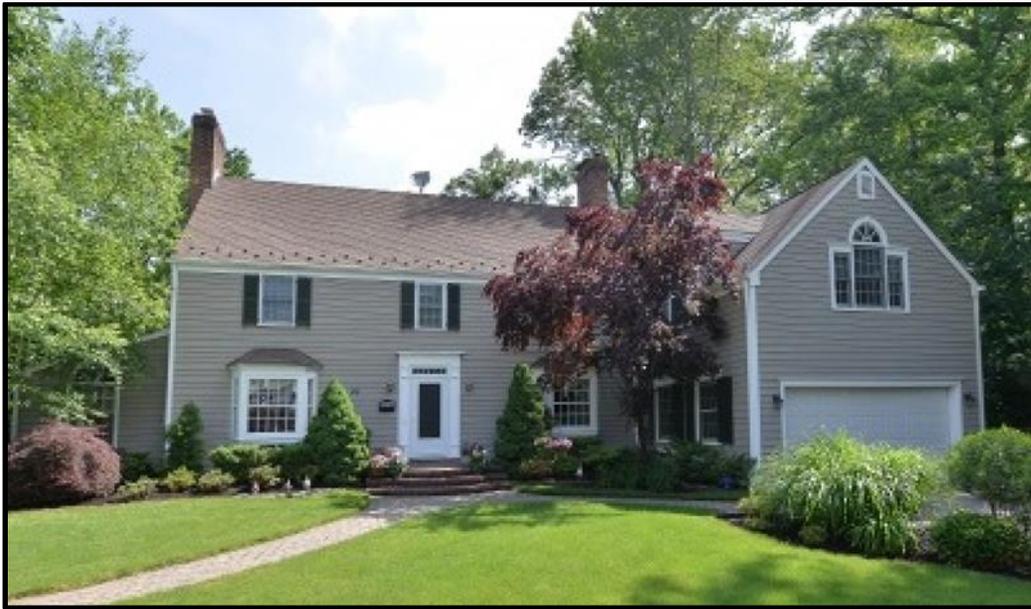
28) 22 Doering Way (Block 198, Lot 30)

22 Doering Way is a 2-story side gable house with a 1-story shed addition at left and a projecting 2-story garage addition at right. Constructed 1937, the house has been extensively altered with replacement windows, inoperable shutters, and vinyl siding throughout.

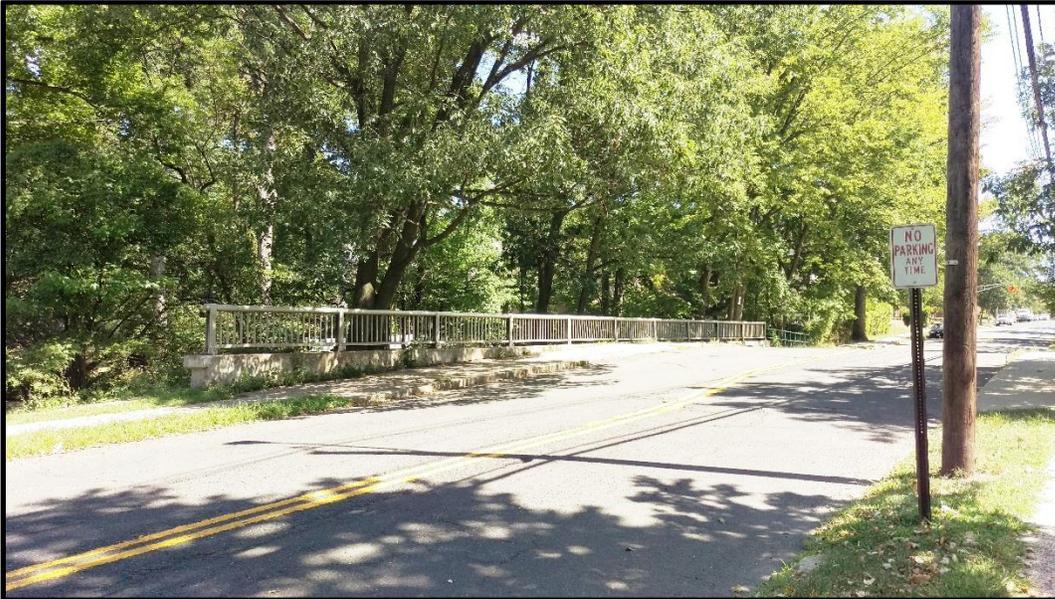
30) Eastman Street Bridge (STR# 2003025), Eastman Street over Rahway River (SE crossing)

The Eastman Street Bridge over the Rahway River (southeast crossing, Structure # 2003025) is a reinforced concrete deck elliptical-arch bridge with concrete paneled spandrels and wingwalls constructed in 1913. The existing aluminum railing, a c1985 replacement, sits atop the low parapet wall and consists of cast aluminum stanchions with round tube top rails and balusters, and a rectangular tube bottom rail. Remnant historic painted pipe railings exist on low retaining walls of the east approach on both sides of the roadway. These are in fair condition and in need of some repair.

The Eastman Street Bridge is a contributing structure within the eligible North Cranford Historic District, Rahway River Parkway Historic District, and Union County Park System. While the 1994 Bridge Survey evaluates the replacement railing as minimally compatible, when future repairs to the bridge are undertaken, it would be appropriate to evaluate a more compatible railing design.

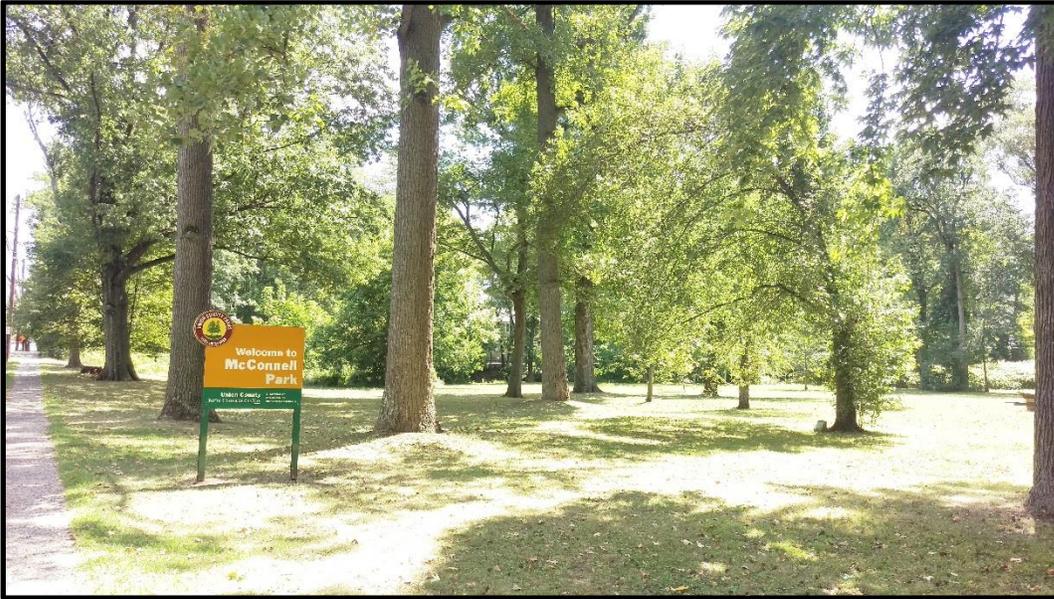
32) McConnell Park, 125 Eastman Street (Block 181, Lot 1)

McConnell Park is a 2.7 acre pastoral park on the north bank of the Rahway River with mature trees and open space. There are no pathways, benches, or other hardscape in the park. A small bronze shield set in a concrete base marks one tree as a memorial to Fannie E. Bates, founder of the Village Improvement Association. McConnell Park occupies the land west of the sharp turn of the river at the foot of Central Avenue, and is part of the Rahway River Parkway and the Union County Park System. .

McConnell Park is eligible as a contributing site within the eligible North Cranford Historic District, Rahway River Parkway Historic District, and Union County Park System.

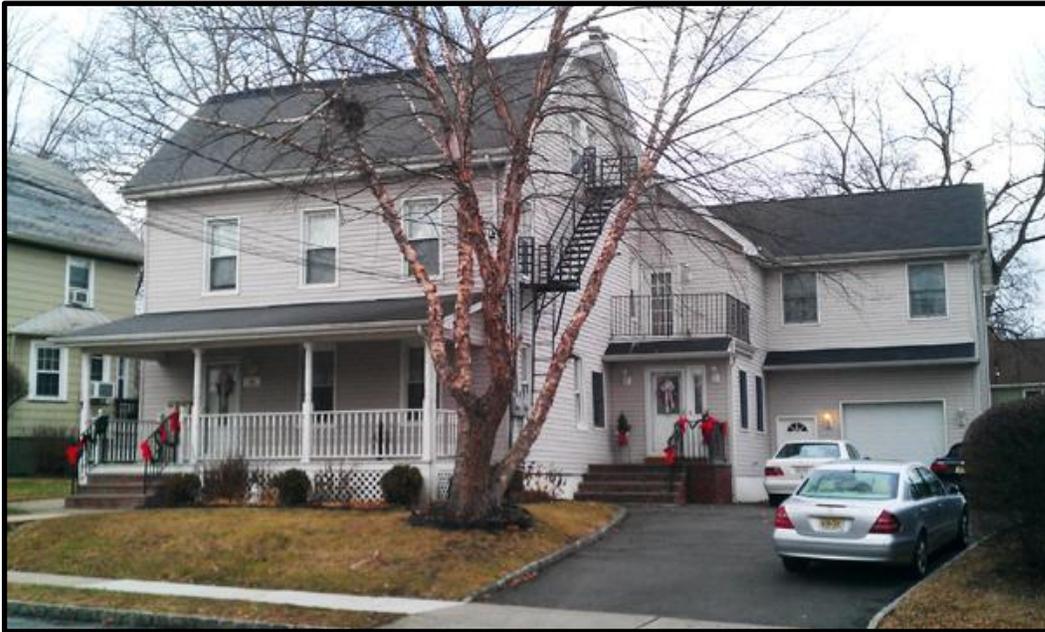
33) 34 Elizabeth Avenue (Block 320, Lot 10)

34 Elizabeth Avenue is a two story side gambrel house with one story shed roof porch across the façade. A two story side gable addition stands behind and right of the main block. Replacement windows and vinyl siding exist throughout. Constructed c1815, the house has been extensively altered, and appears modified for multi-family occupancy; A separate entrance exists in the addition and a fire escape descends from the upper gambrel wall.

The house was noted as significantly altered in the 1981 survey, and has been altered further since that evaluation. Not eligible. No further research or documentation recommended.

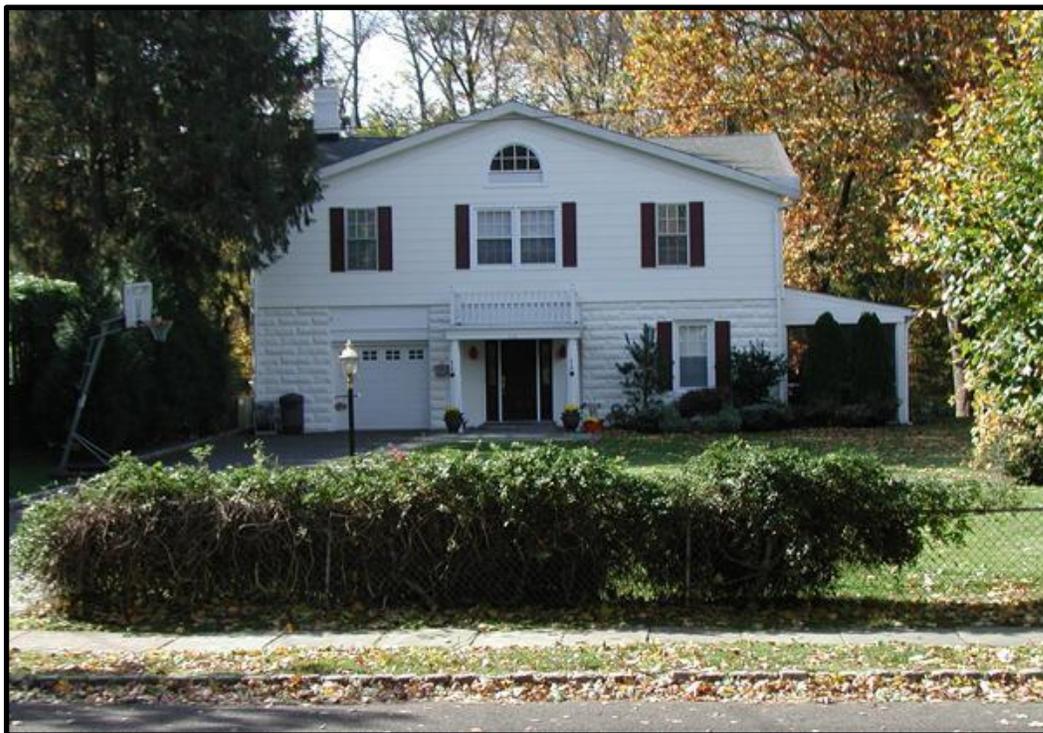
34) 12 Forest Avenue (Block 312, Lot 2)

12 Forest Avenue is a 2-story, 3-bay, cross gable converted carriage house or boat house originally part of the adjacent "Lynwold" property which fronts on North Union Avenue. The 1st story is clad in ashlar blocks, the 2nd story in large shingles. Fenestration is mostly 6-over-6; 8-over-8 directly above the entrance. The side lit entryway has a balustrade portico supported by doric columns. There is a left side internal chimney and a right side covered porch. The residence is set back from the street, and stands immediately adjacent to the Rahway River with the rear foundation wall forming part of the riverbank.

12 Forest Avenue is eligible as a contributing building within the recommended expanded boundary of the eligible North Cranford Historic District.

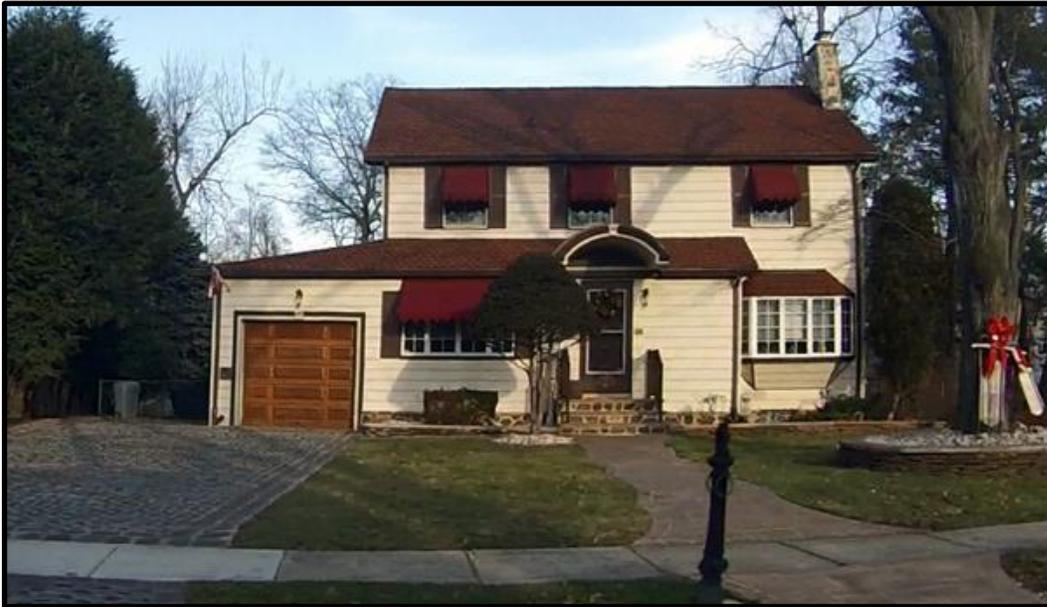
38) 18 Hampton Road (Block 200, Lot 44)

18 Hampton Road is a 2-story side-gable Colonial Revival house constructed c1951 with asphalt shingle roof and stone exterior gable end chimney at right. Exterior siding is aluminum, with a stone foundation. On the second floor windows are double hung with exterior storms, inoperable shutters, and canvas awnings. A hipped roof addition extends from the front and left side with the front entrance in the center and a garage entrance at left. The entrance has an arched hood over the stone portico. A projecting bay window has been added at the right end of the façade.

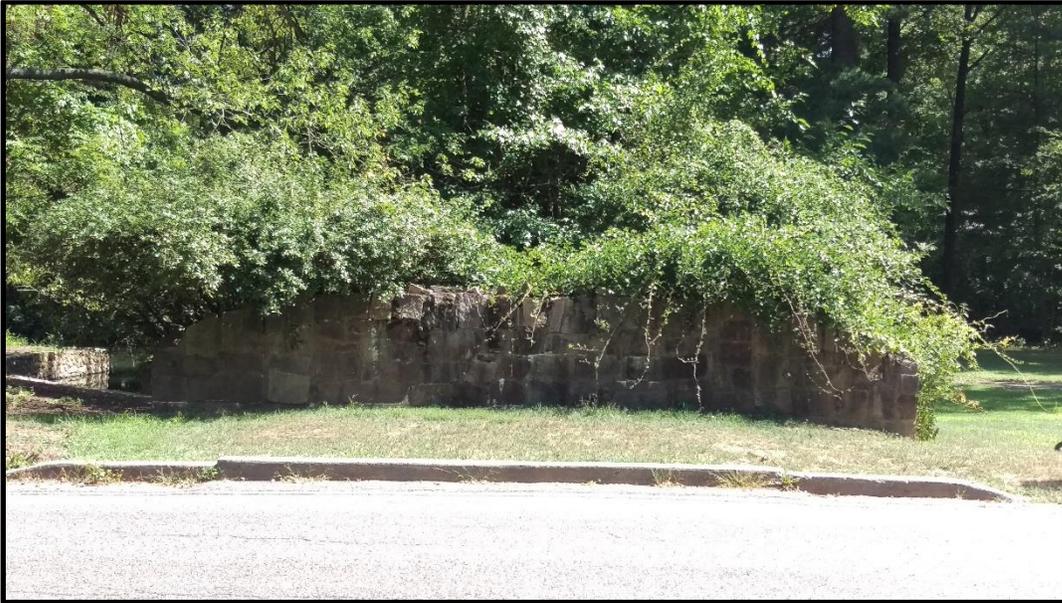
40) Stone Culvert, Hampton Street over Rahway River Tributary

Although evaluated as contributing in the Panamerican Report, the culvert was constructed in 1980 and is therefore a non-contributing structure within the eligible North Cranford Historic District.

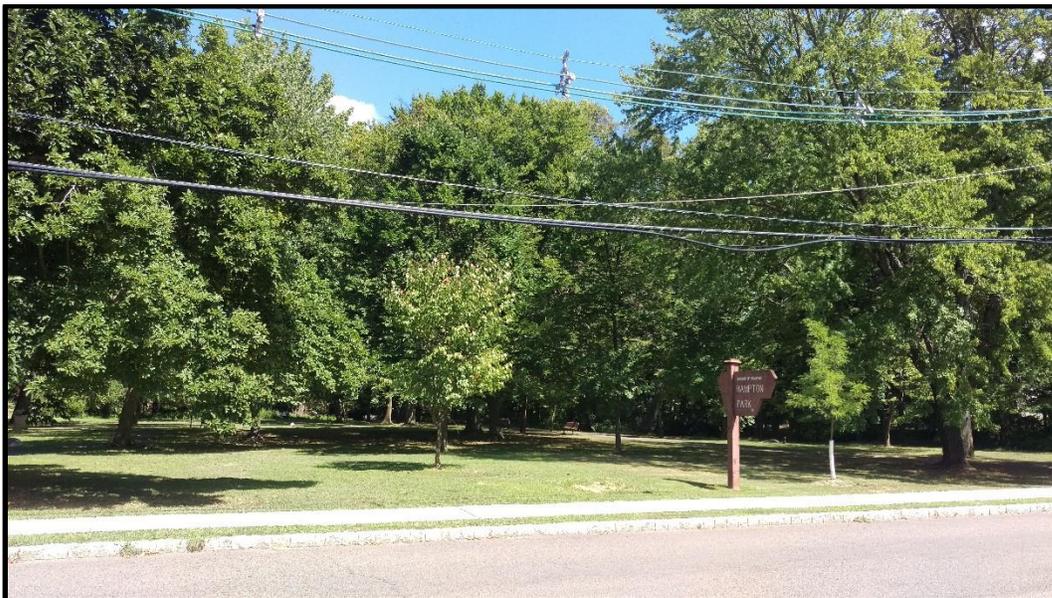
41) Hampton Park, 104 Hampton Street (at Eastman Street) (Block 168, Lot 1)

Hampton Park is a 1.2 acre municipal park on the northwest bank of the Rahway River with mature trees and open space. There are asphalt pathways, benches memorial plaques mounted on stone bases in the park. Remnant concrete steps to the river exist halfway along the river frontage. Hampton Park occupies lot northwest of the river, along Hampton Street between Eastman Street and a small channelized brook. Formerly the site of Hampton Hall, a large residential property that burned in 1969. The land was donated to Cranford Township by the family, which is memorialized on a bronze plaque mounted on a large boulder near the river.

Hampton Park is located within the eligible North Cranford Historic District, and adjacent to the eligible Rahway River Parkway Historic District. Although it was not developed as parkland until well after the periods of significance for the districts, due to its recreational character, it is noted as contributing in SHPO comments regarding the Eastman Street Bridge replacement project.

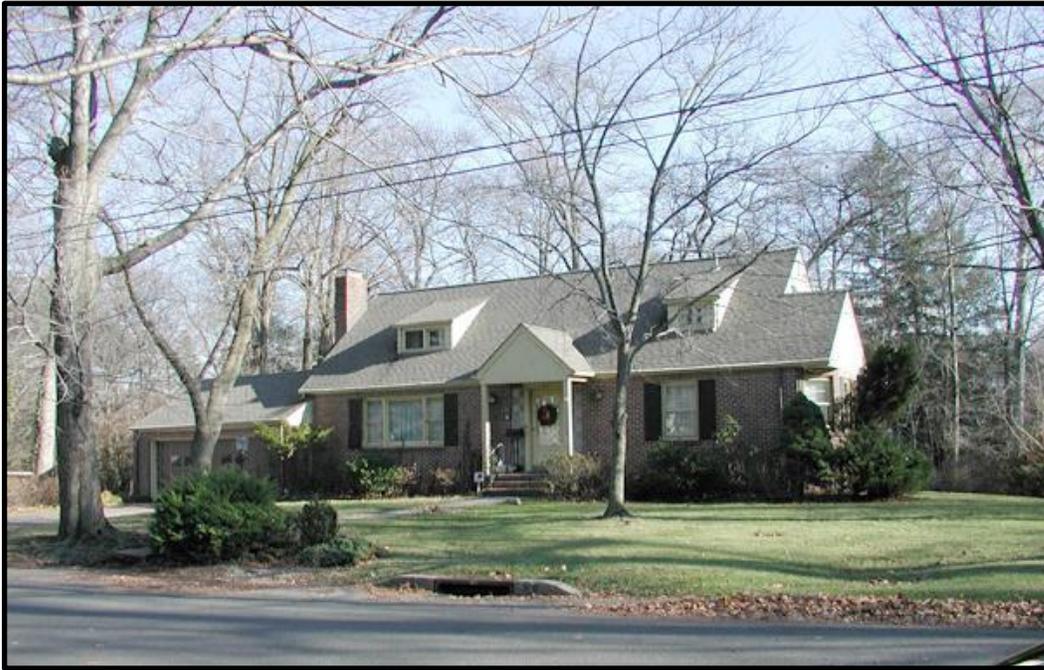
42) 108 Hampton Street (Block 168, Lot 2)

108 Hampton Street stands within the eligible North Cranford Historic District, but its recorded 1951 build date (it replaced a Victorian home which was destroyed by fire.) makes it non-contributing.

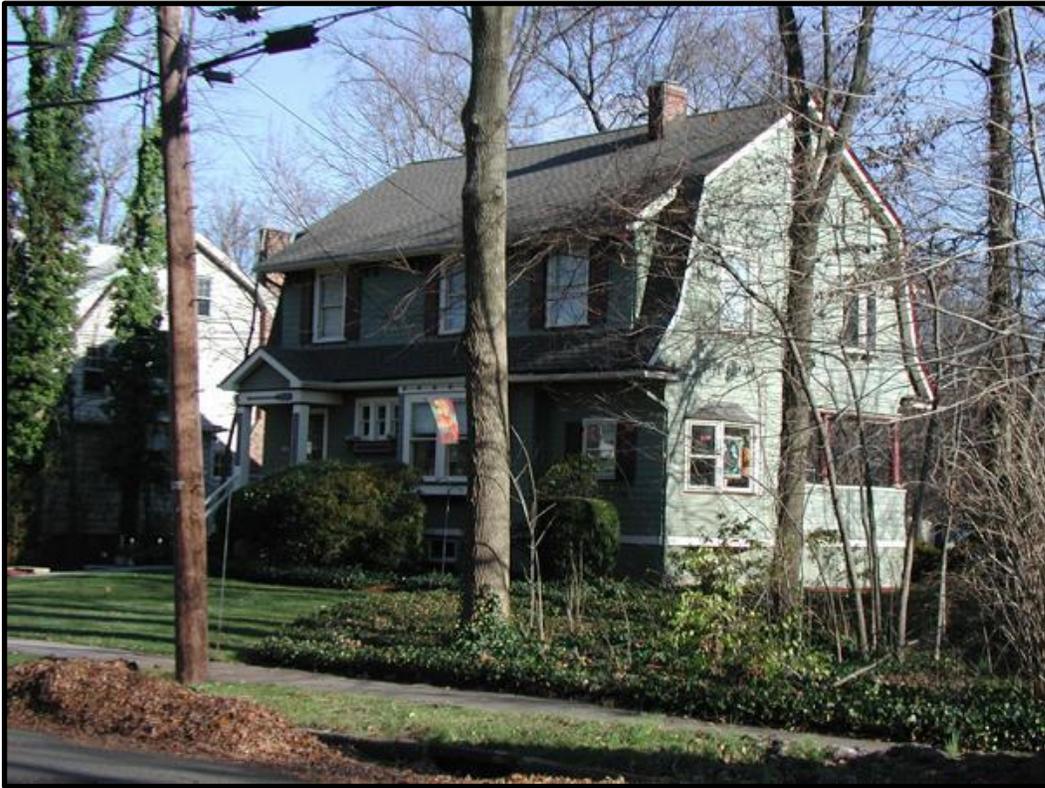
44) 208 Hampton Street (Block 168, Lot 7)

208 Hampton Street is a 2 story, 4-bay, side gambrel Dutch Colonial Revival house. A 3-window shed dormer extends across most of the front. The entryway is found on the left, topped by a gable portico with decorative oar below it. An interior chimney pierces the roof right of center. There is a deep integral interior porch at the left rear corner below the gambrel roof with round Doric columns which provides views of the river to the rear of the property. A square window bay projects under the gambrel eave centered on the front. Fenestration is generally one-over-one. Cladding is plain shingles

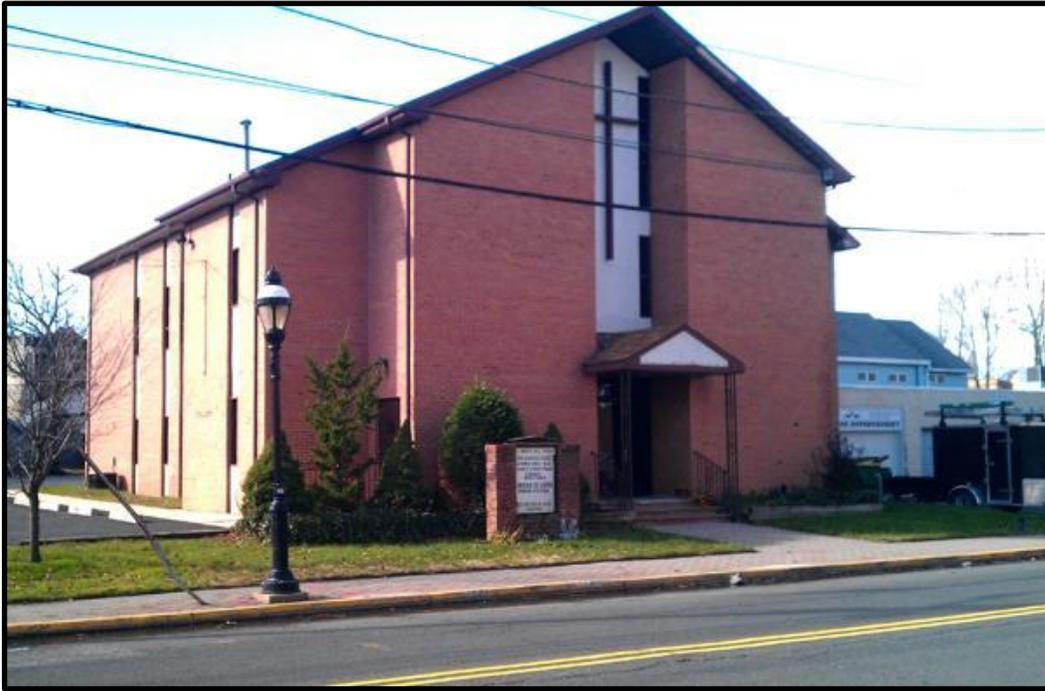
48) Saint Mark's AME Church, 34 High Street (Block 478, Lot 7)

The current Saint Mark's AME Church is a modern church building constructed 1993, replacing the earlier structure identified in the Black Historic Sites survey. Not eligible. No further research or documentation recommended.

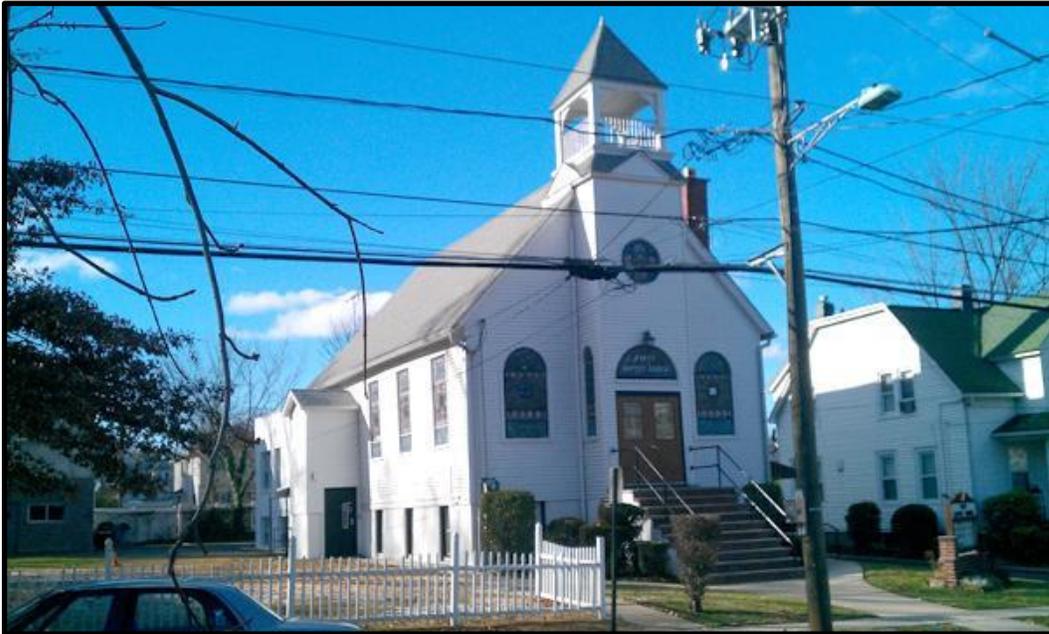
49) First Baptist Church, 100 High Street (Block 484, Lot 22)

First Baptist Church is a small wood frame vernacular Colonial Revival church building constructed c1887, with asphalt shingle gable roof, small central hipped roof bell tower and round-arched stained glass windows on either side of the central entrance. The main entrance is centered in the projecting tower and accessed via brick steps with metal pipe railings. A round arched stained glass pediment window exists above the doorway, with a small round stained glass window centered halfway up the tower. The exterior is vinyl clad throughout, with a stuccoed foundation. A small two-story gable roofed addition stands to the rear on the left side.

First Baptist Church is potentially eligible, but the history of the congregation, interior documentation, and additional historical research should be compiled and further evaluated at Phase 2.

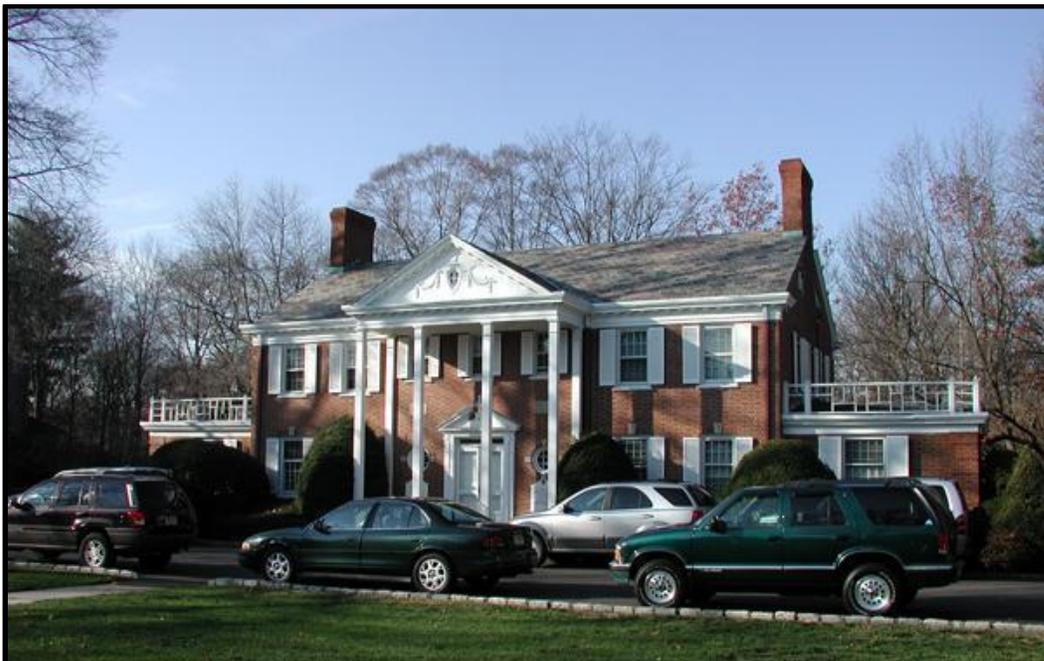
50) Medical Office Building, 19 Holly Street (Block 179, Lot 15)

19 Holly Street is a 2-story, 7-bay, side gable Neo-Classical residential building converted to a professional medical office use. The two story gable roof portico has a shield shaped window with decorative swag molding in the gable end. Eaves have heavy modillion cornices above modern replacement double-hung windows with inoperable shutters. The main entrance has a heavy broken pediment above the transom light and double entrance doors. The entrance is flanked by round key-stoned oriole windows on either side. One story flat roofed side wings topped by wood railings are attached to the left and right gable ends.

19 Holly Street is eligible as a contributing building within the eligible North Cranford Historic District.

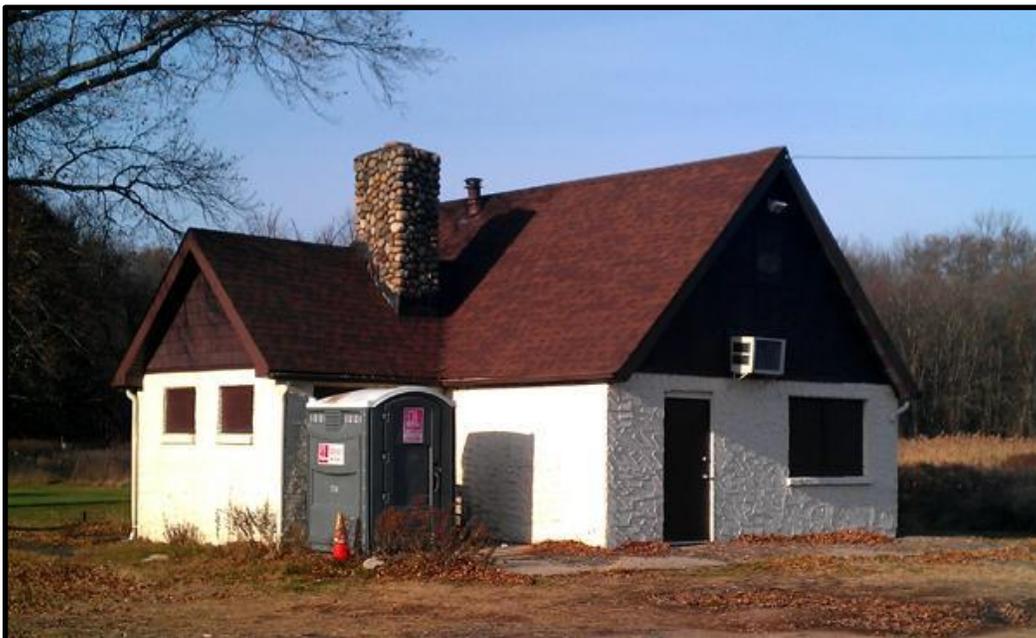
52) Lenape Park Snack Shop, Kenilworth Boulevard (Block 101.01, Lot 1)

The building identified as the “Lenape Park Snack Shop” is a small gable roofed park building with rustic Adirondack style elements. A small gable roofed wing with a rubble stone chimney projects from the main block on the west side. A single doorway is located on the left side of the south gable of the main block. Gables are clad in rustic “live-edge” clapboard and the walls are rough-finished stucco. Windows are boarded up and were not observed.
