**Phase 1 Cranford Historic Resources Survey:
Review of Existing Documentation, Baseline Inventory, and Survey Updates**

Cranford Historic Preservation Advisory Board
Cranford Township, NJ
November 2016

Volume 1: Phase 1 Report

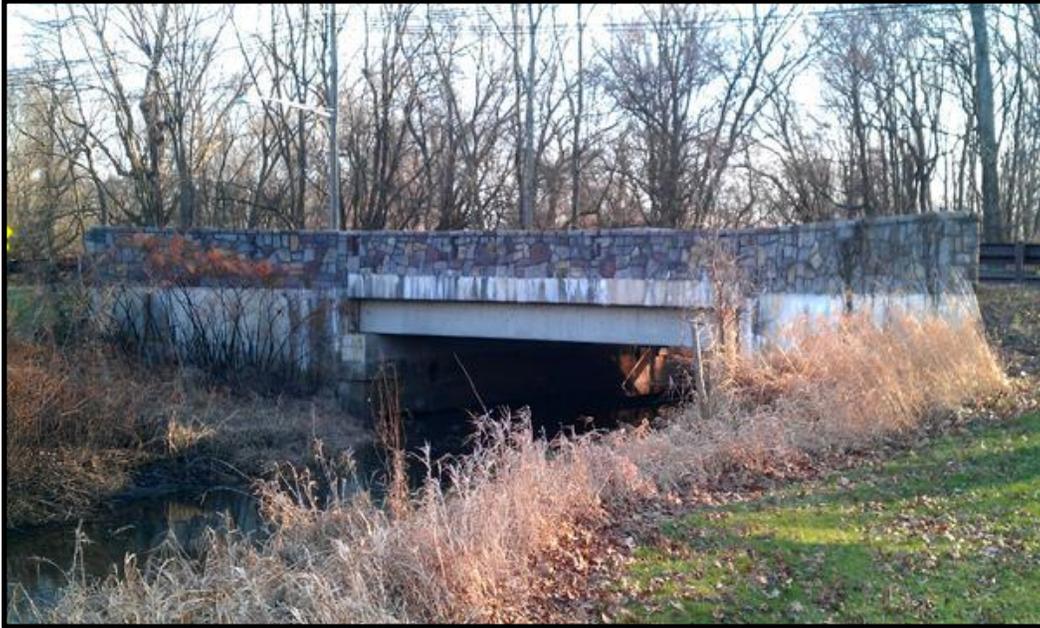
53) Kenilworth Boulevard Bridge (STR# 2003006), Kenilworth Boulevard over Rahway River tributary (West Crossing)

Constructed in 1992, the Kenilworth Boulevard Bridge (STR# 2003006), Kenilworth Boulevard over Rahway River tributary (West Crossing) replaced an earlier structure dating from 1925. The replacement project was underway when the bridge was documented in the NJDOT Bridge survey in 1991 and the original design was not described. The current bridge is a single span concrete box beam structure with stone faced concrete parapets and concrete abutments. This is a design similar to numerous other replacement bridges constructed by Union County and NJDOT in Cranford and surrounding areas.

The Kenilworth Boulevard Bridge (West Crossing) is less than 50 years old, does not meet the criteria for individual eligibility and is non-contributing to the eligible Rahway River Parkway Historic District and Union County Park System. Although the bridge will be included in Phase 2 as part of a comprehensive inventory of resources within the eligible historic districts, no further research or documentation recommended.

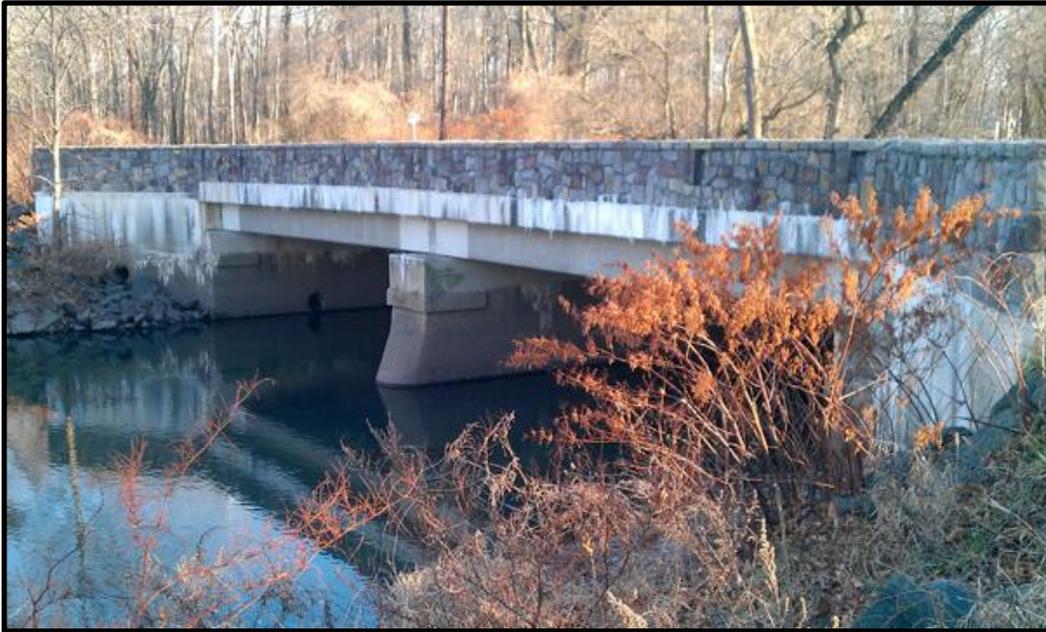
54) Kenilworth Boulevard Bridge (STR# 2003018), Kenilworth Boulevard over Rahway River (East crossing)

Constructed in 1992, the Kenilworth Boulevard Bridge (STR# 2003018), Kenilworth Boulevard over Rahway River (East crossing) replaced an earlier structure (date unknown). The current bridge is a two-span concrete box beam structure with stone faced concrete parapets and concrete center pier and abutments. This is a design similar to numerous other replacement bridges constructed by Union County and NJDOT in Cranford and surrounding areas.

The Kenilworth Boulevard Bridge (East Crossing) is less than 50 years old, does not meet the criteria for individual eligibility and is non-contributing to the eligible Rahway River Parkway Historic District and Union County Park System. Although the bridge will be included in Phase 2 as part of a comprehensive inventory of resources within the eligible historic districts, no further research or documentation recommended.

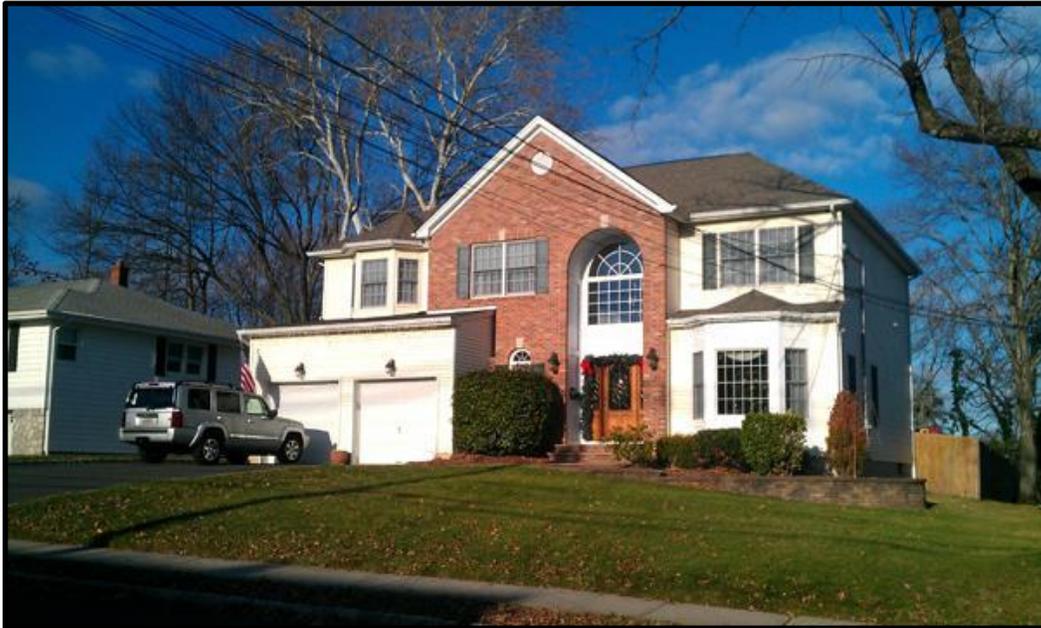
55) Williams House, 506 Lexington Avenue (Block 460, Lot 16)

The Williams House was demolished and replaced with this modern house in 2003. Not eligible. No further research or documentation recommended.

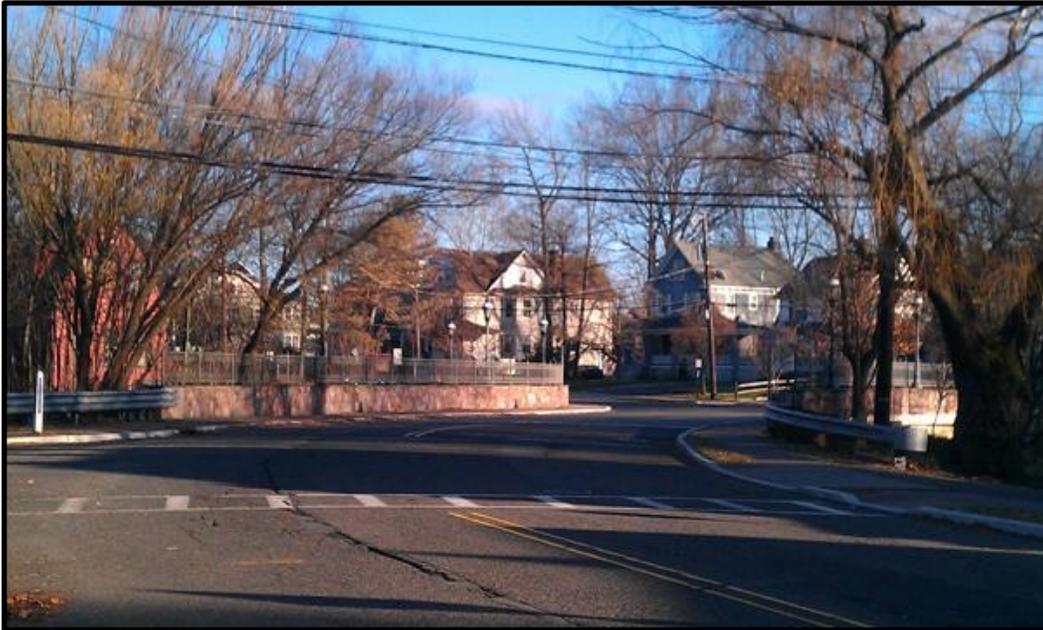
56) Lincoln Avenue/High Street Bridge (STR# 2003045), Lincoln Avenue/High Street over Rahway River

Lincoln Avenue High Street over the Rahway River was replaced with the current structure in 1996. The current bridge is a concrete stringer bridge, with concrete deck supported on concrete abutments. The structure was designed to be compatible with Droscher's Mill, incorporating stone faced parapets with tinted mortar and decorative steel railings, a design similar to numerous other replacement bridges constructed by Union County and NJDOT in Cranford and surrounding areas.

The bridge is less than 50 years old, does not meet the criteria for individual eligibility and is non-contributing to the eligible Rahway River Parkway Historic District and Union County Park System. Although the bridge will be included in Phase 2 as part of a comprehensive inventory of resources within the eligible park districts, no further research or documentation recommended.

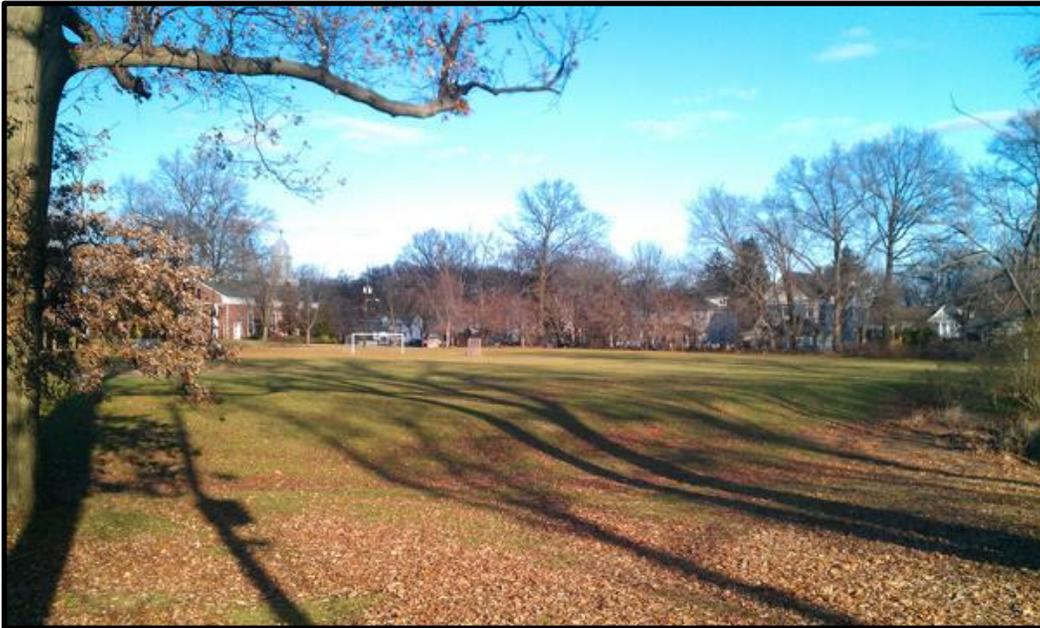
57) Sherman Park, 150 Lincoln Avenue E (Block 488, Lot 8)

Sherman Park is a 4 acre park with an athletic field along Lincoln Avenue, and a stand of mature trees along Denman Avenue known as Ditzel's Grove. The park was created in 1978 after demolition of Sherman School. Ditzel's Grove, dedicated in 1986, is marked by a metal plaque affixed to a large boulder that reads, "Named in Recognition of the Contribution of the Ditzel Family to Cranford." The park is less than 50 years old and does not meet the criteria for individual eligibility. Not eligible. No further research or documentation recommended.

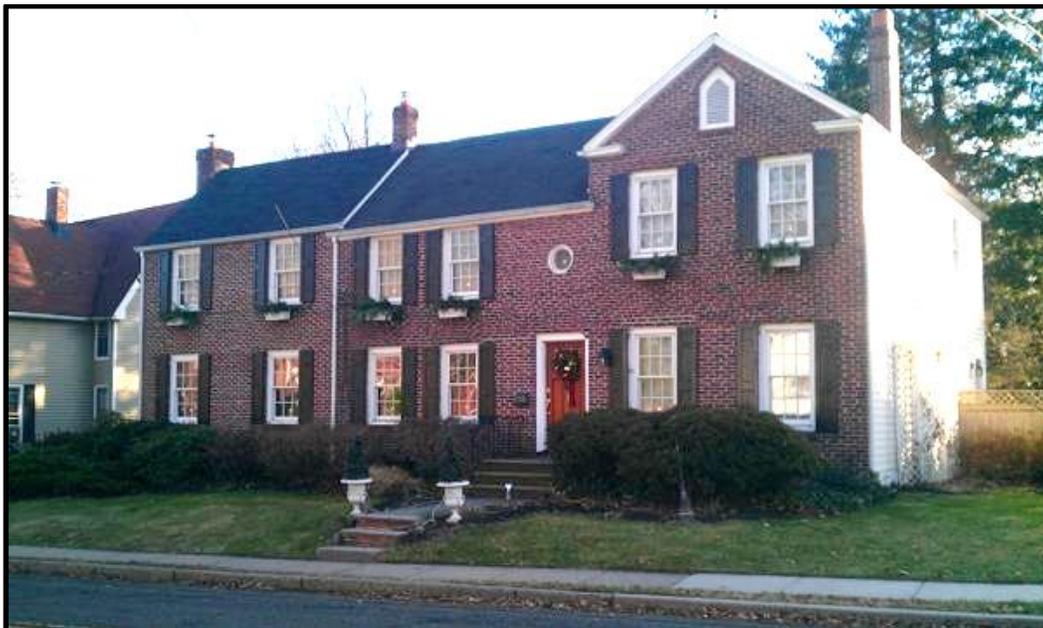
58) Vreeland Home, 306 Lincoln Avenue E (Block 497, Lot 20)

The house is referenced in the Union County Historic Sites Survey as the "Vreeland Home (Site)" but the form is not included in the survey, nor is it assessed on the summary list of eligibility findings; It is however indicated on the survey index map, appears in the general street index of resources, and is included with the set of photographs for the Cranford volume. A house is shown at this location on the 1839 US Coast Survey Map, but additional research and documentation at Phase 2 are necessary to establish the significance of this house.

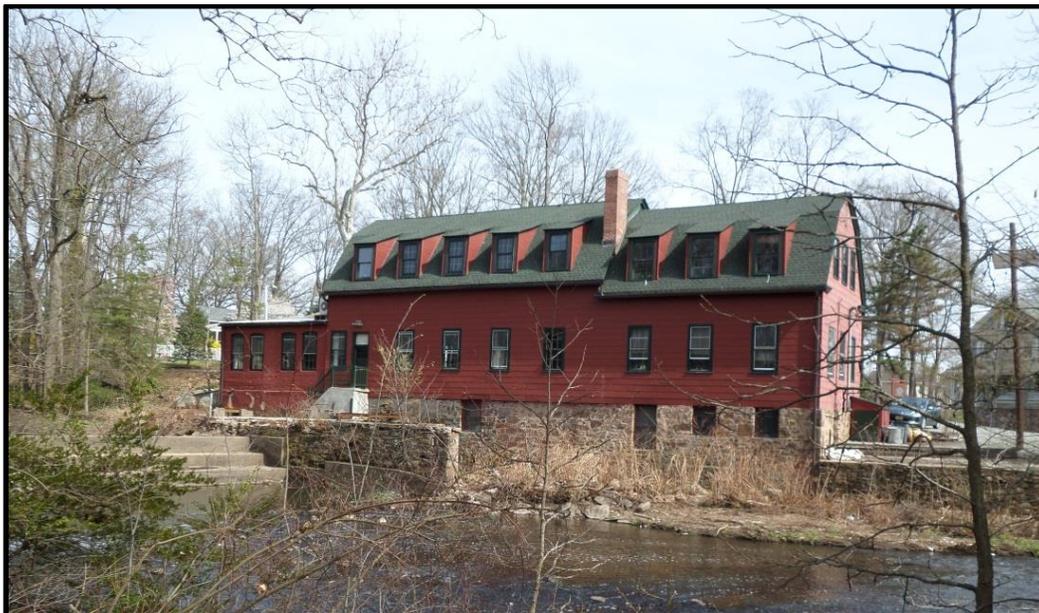
59) Williams-Droeschers Mill, 347 Lincoln Avenue E (Block 482, Lot 2)

The Williams-Droeschers Mill is listed on the NJ and National Registers of Historic Places, and was designated as a local landmark by Cranford Township in 2014. As described in the recommendation report prepared April 2014:

The Droeschers Mill building is two stories high with a gambrel roof, constructed of wood with a semi-coursed stone foundation. Some of the stone appears to be local fieldstone, in other areas cut stone of different varieties was used. The building is approximately 105 feet in length and 30 feet in width. It has a single-story, shed-roofed, brick addition on its northeast end (See full designation report, Appendix A)⁸.

Shed dormers punctuate the gambrel roof on both sides, and cladding is wood clapboard of varying widths throughout. Windows are generally 6-over-6 wood double-hung. Based on the extensive documentation and recent landmark designation of this significant resource, no further research or documentation recommended at this time.

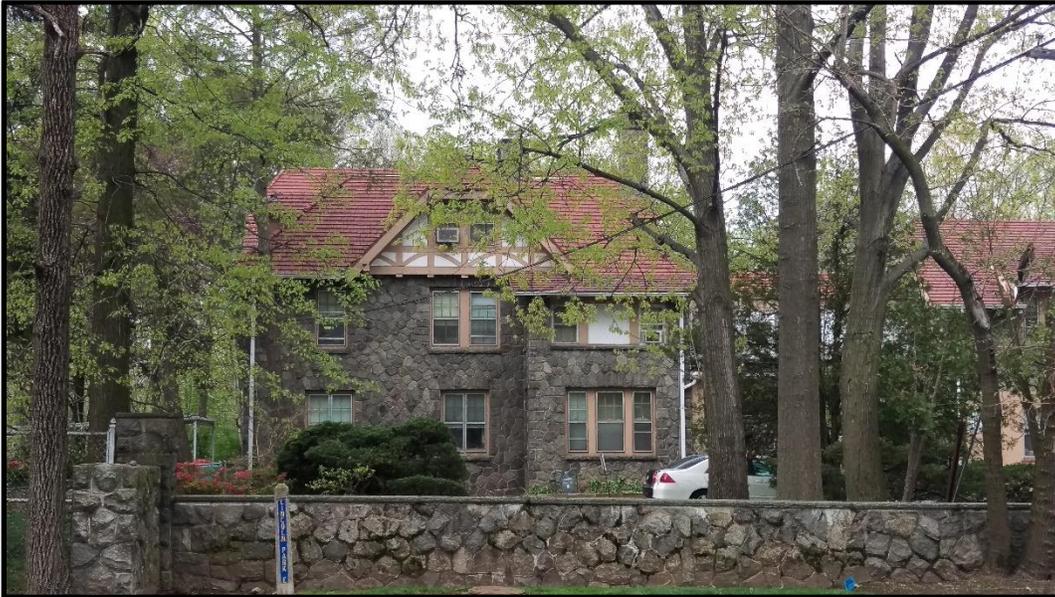
60) Cranford Hall, 600 Lincoln Park E (Block 505, Lot 2)

Cranford Hall is a large former estate converted to institutional use as a nursing facility c1935. The property includes the former home (c1912) of the Kaltenbach family on the left, and a modern residential facility (c1950) on the right. A low stone wall with stone gates lines property along Lincoln Park East. The house was described in the 1984 survey as a "Norman Castle" style house, with stone walls, half-timbered gables, and octagonal crenelated stone tower. However, the orientation of the house and the wooded lot makes existing conditions difficult to document without accessing the interior courtyard between the two buildings. Additional research into the significance of the Kaltenbach's is necessary to fully evaluate the significance of this property. Additional research and documentation will be included at Phase 2.

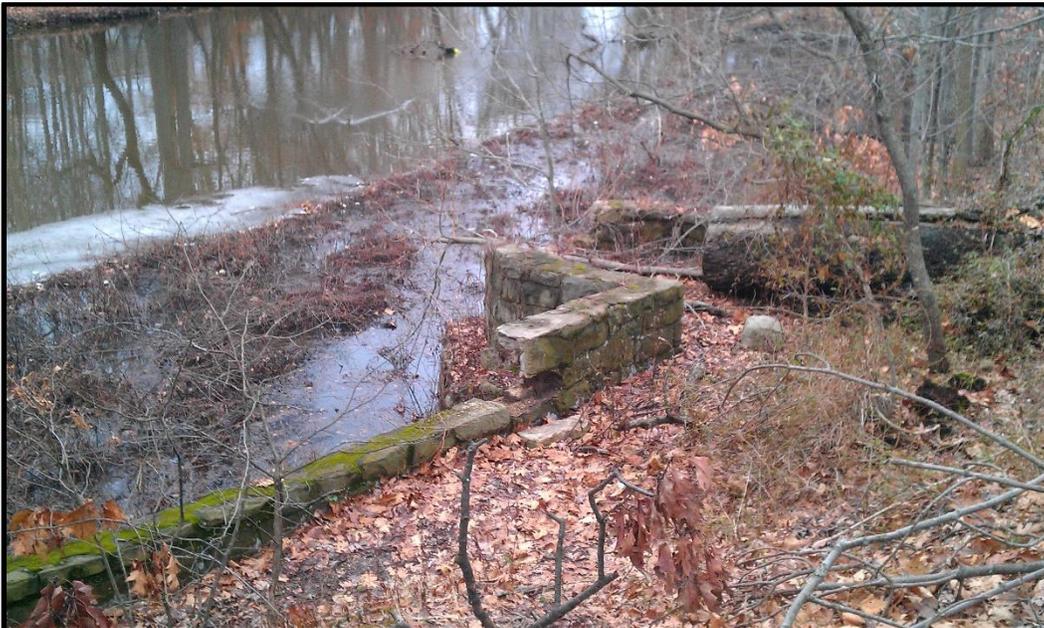
61.2) Stone Overlook, Walking Path in Lincoln Park Section (Block 482, Lot 1)

This structure is located between the Lincoln Park walking path and the Rahway River approximately 50' from the south end of the path where it intersects Lincoln Park East. The overlook consists of a low stone wall approximately 30' long paralleling the river, with a semi-circular overlook 15' in diameter projecting towards the river. The parapet of the overlook has been damaged from a fallen tree that partially blocks access to the structure. Portions of the structure may date to the late 19th century:

The overlook is eligible as a contributing structure within the Lincoln Park Section of the eligible Rahway River Parkway Historic District and Union County Park System, and will be included in Phase 2 as part of a comprehensive inventory of resources within the eligible districts. Given the deteriorating condition of the structure, HPAB recommends that the county assess structural integrity and implement stabilization to ensure preservation of the structure. Future work should include comprehensive rehabilitation and pedestrian improvements to enable access to the overlook.

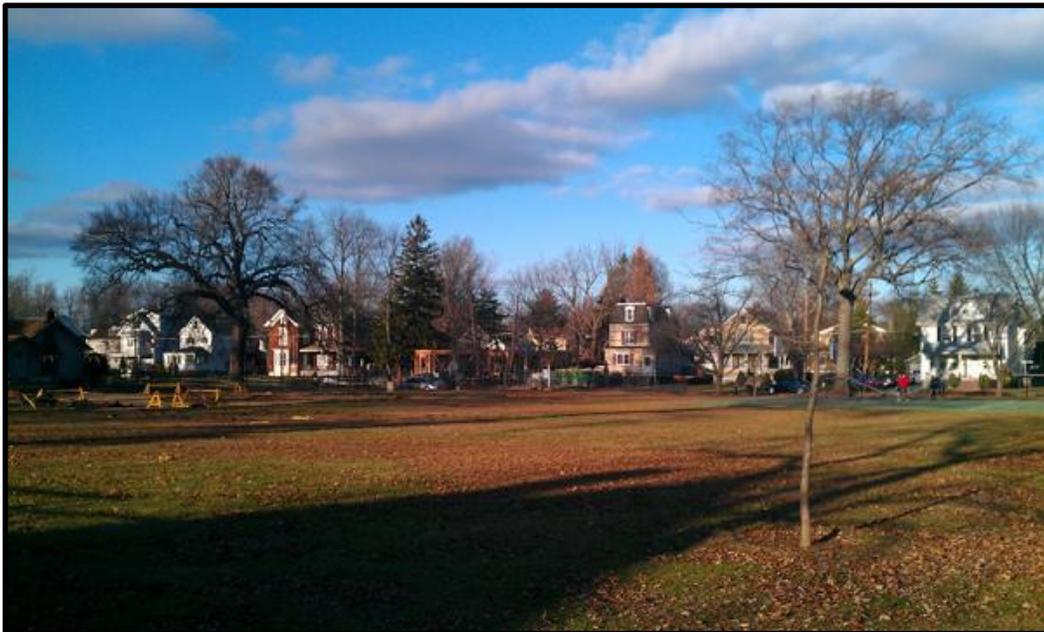
63) Lincoln Park, 15 Lincoln Avenue W (Block 421, Lot 3.01)

Although it is unclear when the improvements were made, the park has been altered over time, and does not to have any significant historic associations. The park does not appear to meet the criteria for individual eligibility and is not located in any existing or potential historic district; No further research or documentation recommended.

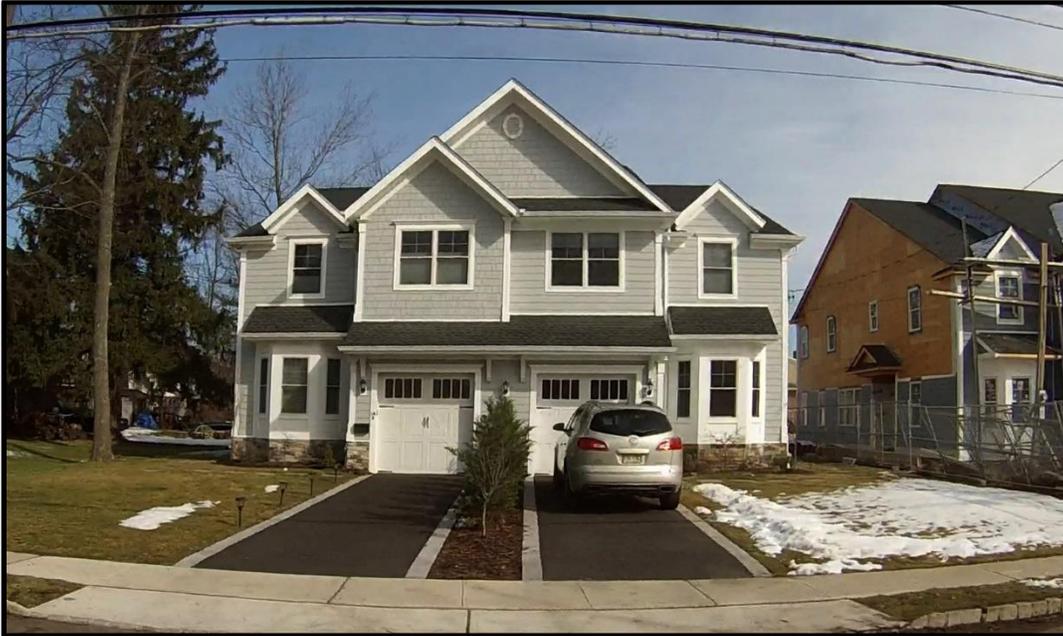
64) 18 Lincoln Avenue West (Block 473, Lot 47)

18 Lincoln Avenue West was demolished and replaced with this modern house in 2015. Not eligible. No further research or documentation recommended.

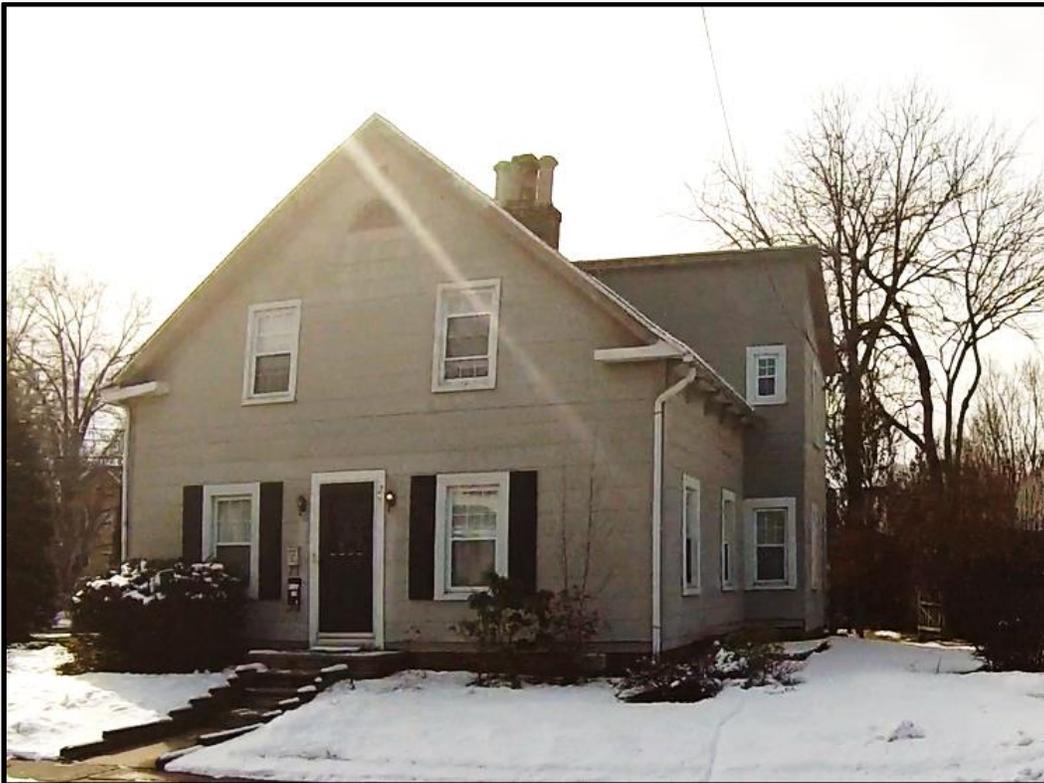
65) 29 Lincoln Avenue West (Block 420, Lot 2)

Although recommended as Not Eligible in the Union County Historic Sites Survey, it notes that the house may date to the 18th century. A building is shown at this location on the 1839 US Coast Survey map, but tax data cites the construction date as c1870. Additional research and documentation are necessary to establish the construction date and potential significance of this house, which will be included in Phase 2.

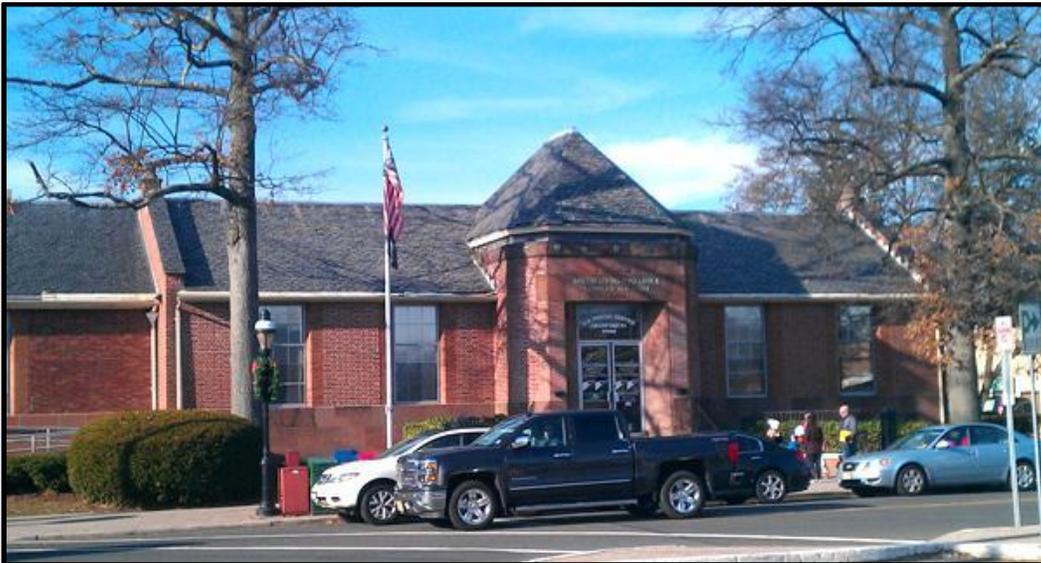
66) Cranford Post Office, 3 Miln Street (Block 181, Lot 10)

This building was evaluated as Not Eligible in the 1982 survey of US Post Offices. At the time it was just 50 years old, and had not achieved a level of significance that we can better appreciate today. The Cranford Post Office is Eligible at a local level of significance under Criterion A for its association with the WPA, and under Criterion C as an intact and well preserved example of standard Postal Service architecture modified for local use. Additional research and documentation at Phase 2 may also reveal Cold War significance associated with the Civil Defense facilities located in the building's basement, as well as for the work of the mural artist Gerald Foster.

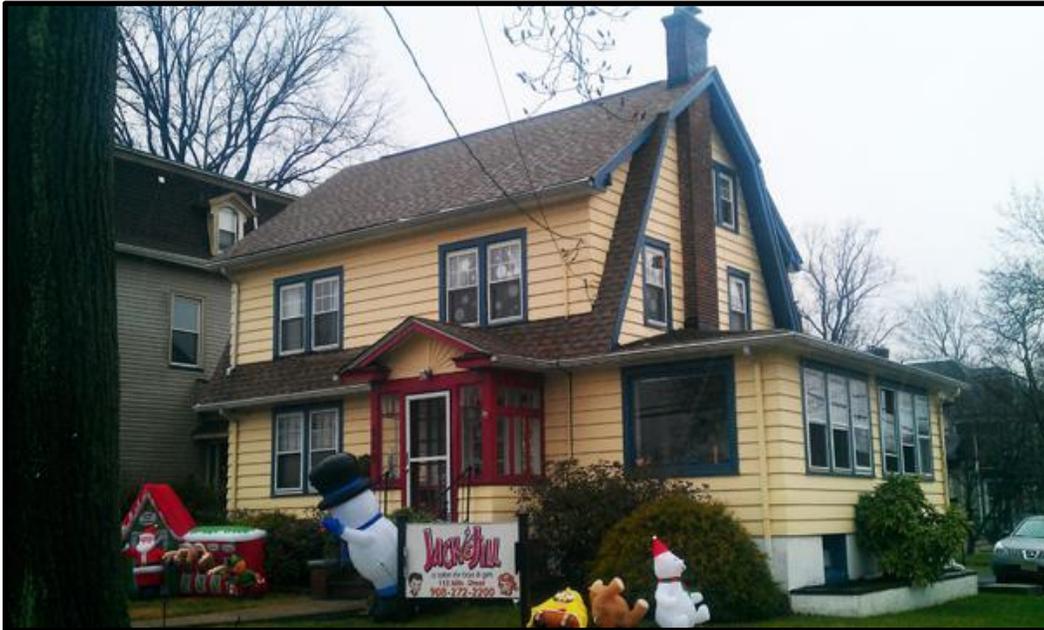
67) 115 Miln Street (Block 187, Lot 14)

115 Miln Street is a two-story Dutch Colonial Revival house with side gambrel roof and full-width shed roof dormers on the second story. The asphalt shingle roof has overhanging eaves and an external chimney on the right side. A one story hip-roof addition is located on the left side. Cladding is wood and windows are vinyl replacements throughout. The main entrance is sheltered by an enclosed gable roofed portico with sunburst molding in the gable and gable returns. The portico is accessed by low brick steps with metal handrails.

115 Miln Street is located at the corner of Miln and Alden Streets, at the edge of the commercial core of downtown Cranford. Currently used as a daycare center, the house does not have any significant associations, and does not appear to meet the criteria for individual eligibility. Although it is adjacent to the edge of the North Cranford Historic District, Miln Street is significantly altered such that it would not form an integral part of the district. No further research or documentation recommended.

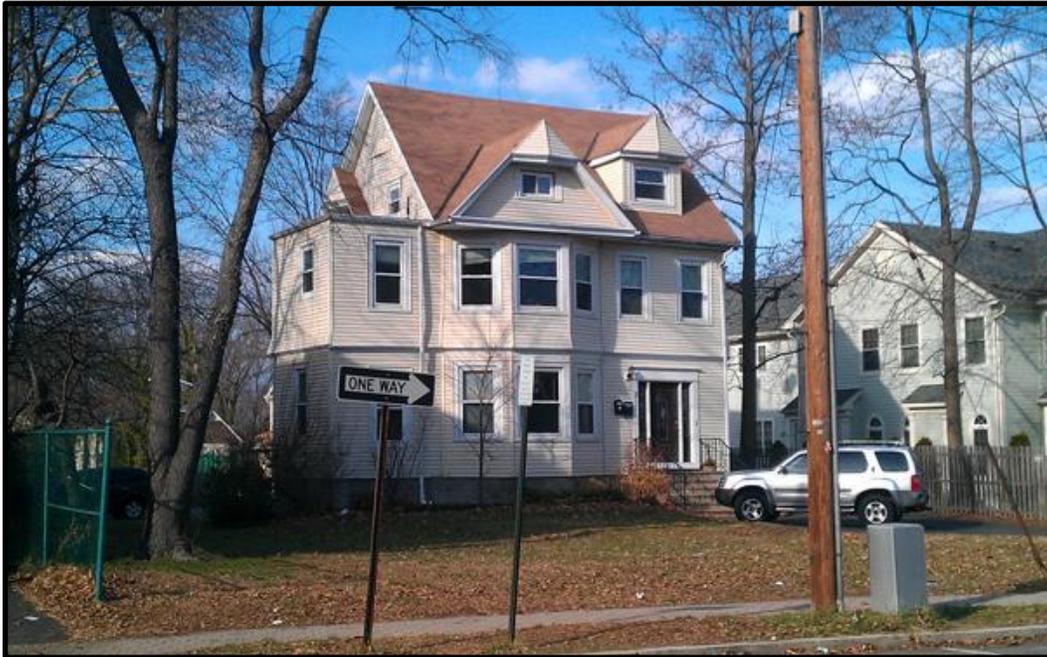
68) 211 Miln Street, (Block 188, Lot 13)

211 Miln Street is a 2 ½ story Queen Anne house constructed c1890 that has been significantly altered. The side gable asphalt shingle roof has a large gabled dormer with over a projecting bay on the left of the façade. A smaller gabled dormer is located at the right side of the front roof slope. A two-story flat roofed addition is attached to the left gable end. Cladding is vinyl siding; windows are one-over-one vinyl replacements throughout. Ornamentation and architectural detail appear to have been removed or obscured, and the house has been subdivided for multi-family occupancy.

211 Miln is located within the revised boundaries of the North Cranford Historic District, but is non-contributing due to lack of architectural integrity. The house is included in the comprehensive inventory of the eligible historic district below, but no further research or documentation recommended.

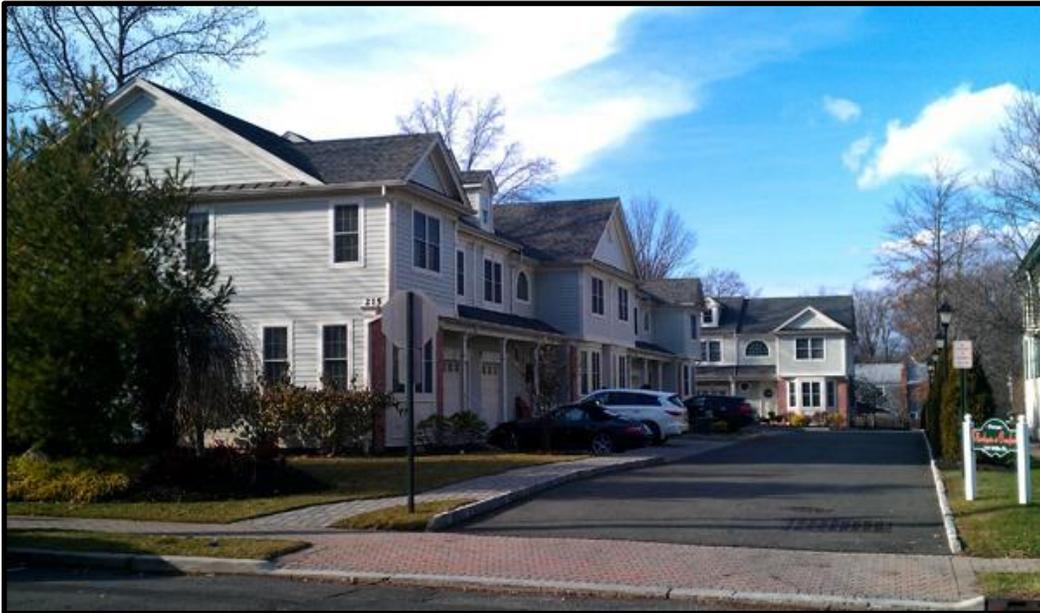
69) 215 Miln Street (Block 188, Lot 12)

215 Miln Street was demolished and replaced with this modern condominium complex in 2007. The complex is located within the revised boundaries of the North Cranford Historic District, but is non-contributing. No further research or documentation recommended.

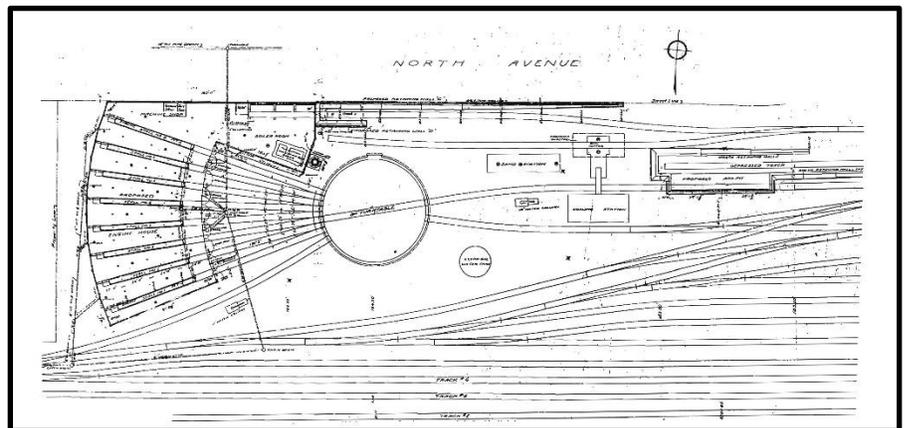
Original plans for roundhouse and turntable (NJ Transit)

The original roundhouse section, constructed between 1913 and 1915, consists of a large eight-bay brick roundhouse structure with shed-roof in a circular arc. A lower shed roof section with opposite roof slope stretches along the east (concave) façade. An additional two-bay structure is connected to the north end of the original block along North Avenue. At the center of the yard where the turntable was located is a modern one story maintenance building constructed c1960.

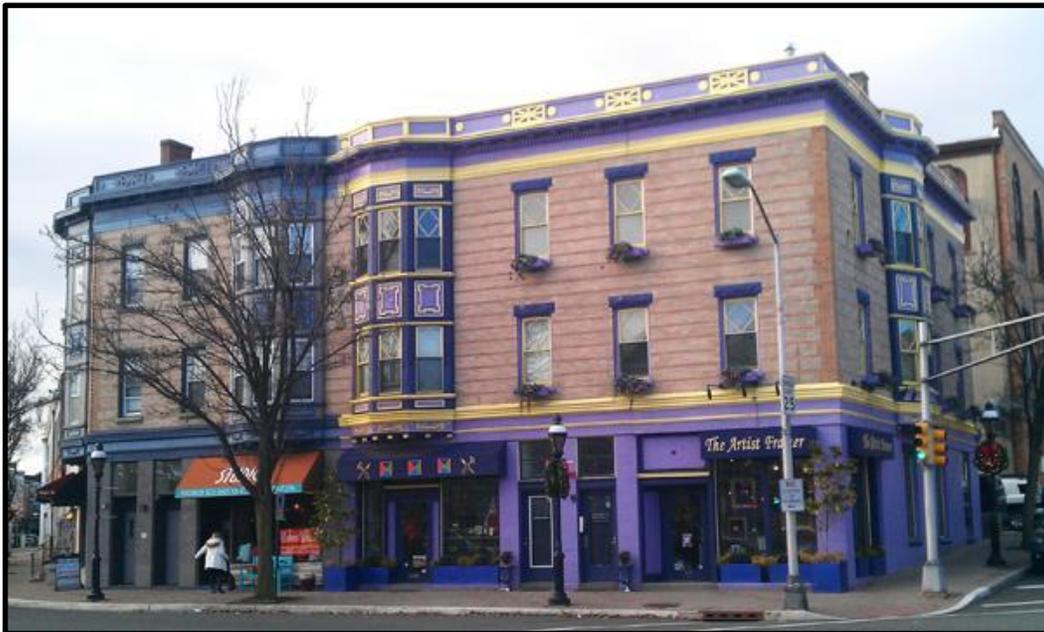
74) William Sperry Building, 11-17 North Avenue (Block 192, Lot 6 and 7)

UCCHPAB 1984: Eligible

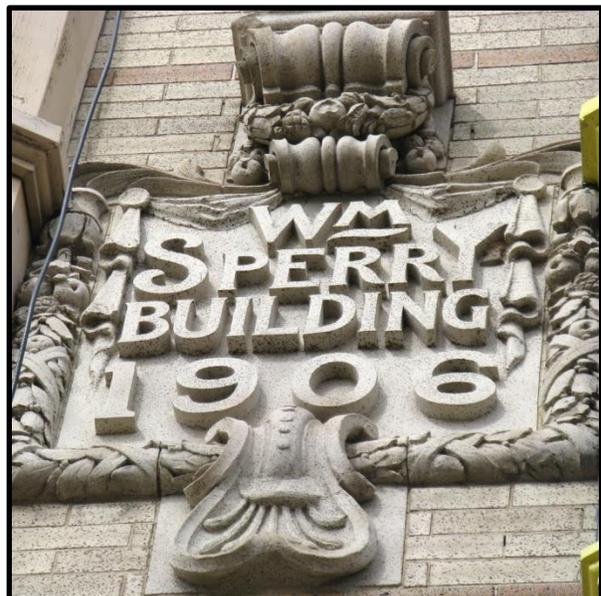
Photo: HPAB 2012

Three sided projecting bays exist on each façade with swag panels above and below the windows. Cladding is buff brick with horizontal bands and quoins of darker brick on the street frontages. Windows have stone sills and headers, and in the eastern half are original 5-over-1 with large center diamond pane in the upper sash, while windows in the western half are modern replacements. Windows and doors in the ground floor storefronts have been modified. An ornate stone cartouche on the North Avenue façade between the bays above the 2nd floor is inscribed "Wm Sperry Building, 1906."

The building stands on two lots under separate ownership, but has been well maintained and remains an

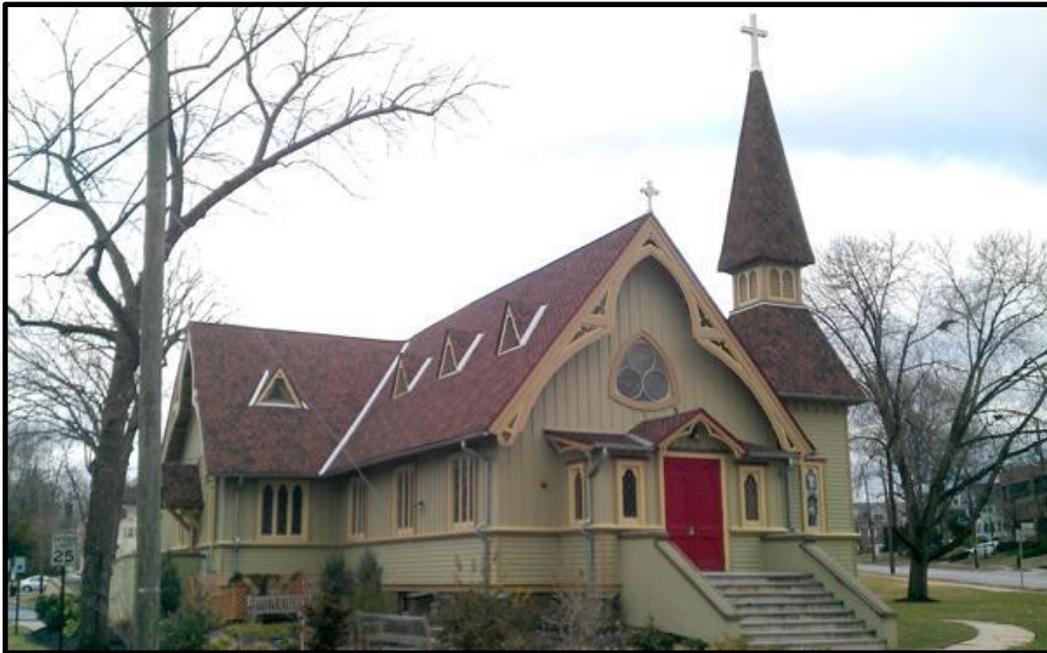
76) Trinity Church, 205 North Avenue E (Block 315, Lot 1)

Trinity Episcopal church typifies the Gothic Revival form of an English country church often found in American Episcopalian churches of the mid to late 19th century. Its cruciform, cross-gabled style, executed here in stucco, exemplifies the form with its steeply pitched roofs... The trefoil motif bargeboard, applied on all of the gable ends is a prominent feature, as are the triangular dormers piercing the roofs of both gable roofs. The dormers contain decorative molding on their gable ends, and they house triangular leaded-glass windows. Stepped buttresses enhance the corners of the building, the corners of the tower, and also appear between the windows on the nave¹³. (WHSS 2002)

The church underwent significant exterior rehabilitation in 2013 which completely transformed the exterior. All stucco finishes were removed, and replaced with wooden siding (vertical board and batten siding above the drip molding, and horizontal lapped siding below). The crenellated portico was similarly sided and a shed roof with cross gable added. The tower was also significantly changed with a frame hipped roof spire replacing the former crenelated flat roof. The bargeboards and triangular dormers

The 2002 survey recommends the church as individually eligible under Criterion B for its association with Alice Lakey, prominent in the consumer safety movement of the early 20th century, but continued individual eligibility hinges on additional research into the source of the recent changes and how they impact the architectural integrity of the resource. If it can be documented that the current design has restored the building to its historic or original appearance, and that the stucco finishes and buttresses were later changes, then the building likely remains individually eligible. Additional research and documentation to address these issues will be compiled at Phase 2.

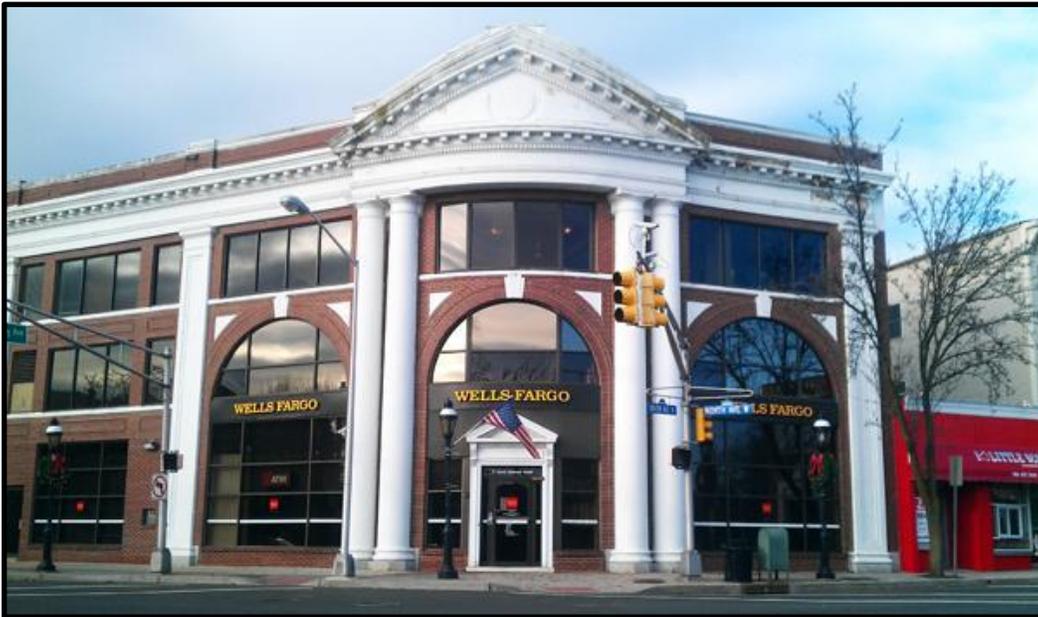
77) Cranford Trust Building, 2-30 North Avenue W (Block 189, Lots 1, 2, 3, 4, 5, 6, and 7)

Cranford Trust Building was constructed in 1913 by the M. Byrnes Construction Company after the former structure, the Cranford Opera House, burned in 1912. While there have been some changes, this imposing building dominates the commercial core of Cranford's downtown, and retains its Classical Revival architectural character. The Cranford Trust Building is eligible for the National Register under Criterion C at a local level of significance as a well preserved Classical Revival commercial building.

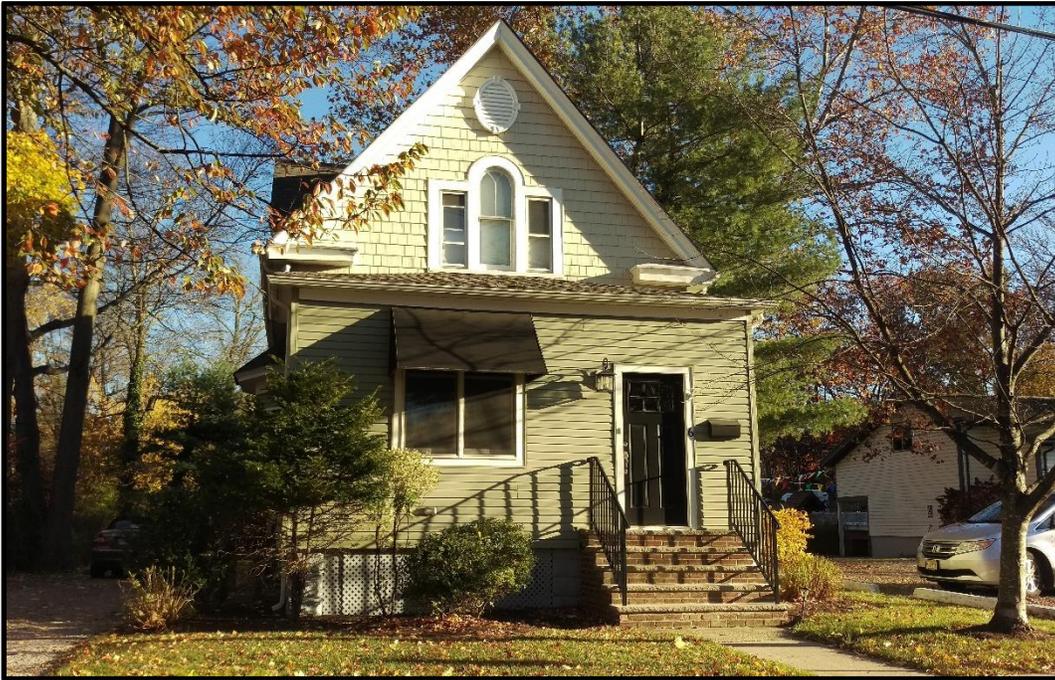
78) 6 Orange Avenue (Block 261, Lot 2)

6 Orange Avenue is a gable end, 2-story, 2-bay cross gable house with Italianate elements. A Palladian window is centered in the front gable end which also has gable returns above a one story hip-roof porch, now enclosed. Cladding vinyl siding. Foundation is rusticated block.

6 Orange Avenue is eligible as a contributing building within the eligible North Cranford Historic District.

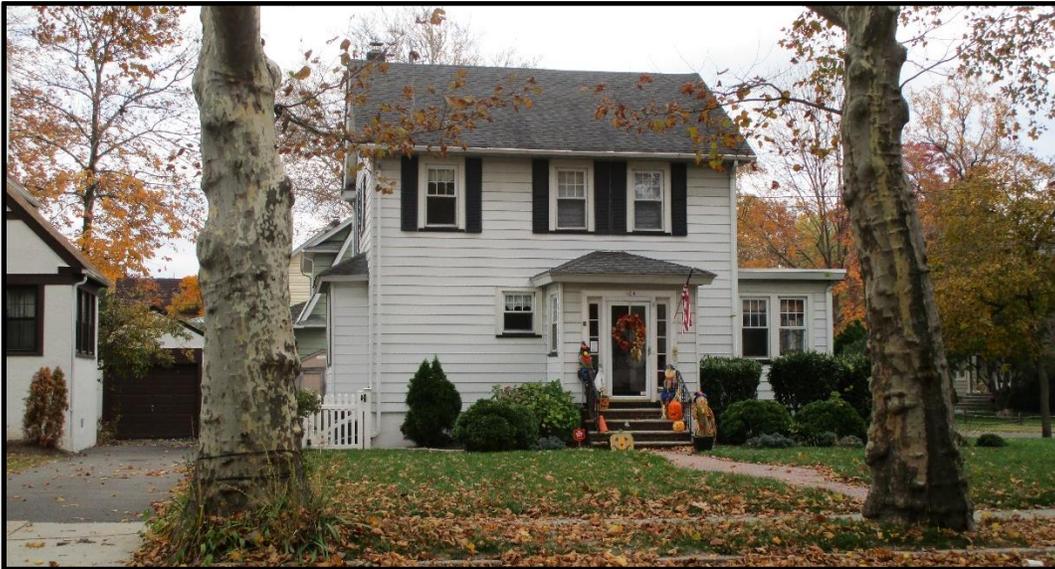
81) 104 Orange Avenue (Block 264, Lot 2)

104 Orange Avenue is a two story side-gable house with asphalt shingle roof, brick chimney at left in the rear, and gable returns. A hipped roof portico encloses the front stoop accessed by brick steps, and a one story flat roof addition exists on the right gable end. Windows are vinyl replacements with inoperable shutters Walls are clad with vinyl siding.

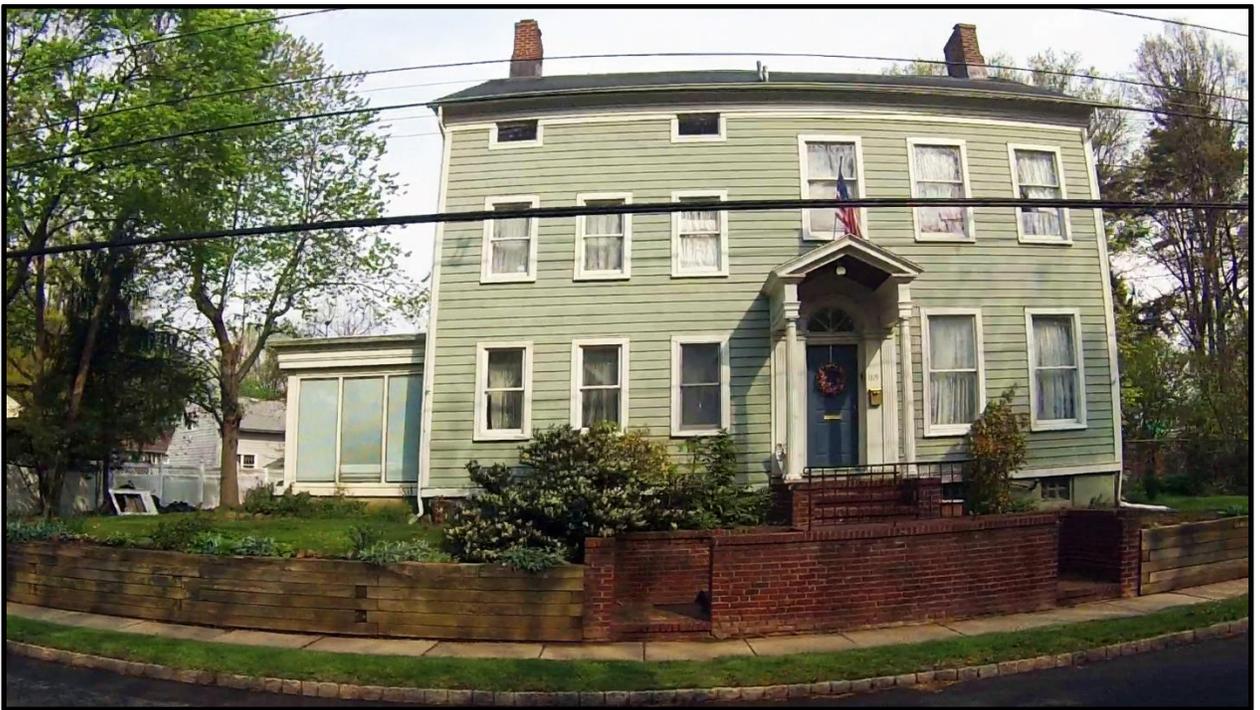
82) Norris-Oakey House, 1119 Orange Avenue (Block 257, Lot 13)

The house was recommended as individually eligible in 1984, and despite recent changes, retains its essential character, and is individually eligible under Criterion C as a

relatively intact and well preserved vernacular Federal style farmhouse representative of Cranford's early agricultural history. The survey form notes a late 1970's CDGB funded restoration project that was halted due to inappropriate treatment, but the extent of changes caused by that project are currently undocumented. Additional research into the architectural evolution of the house, and its early history will be documented at Phase 2.

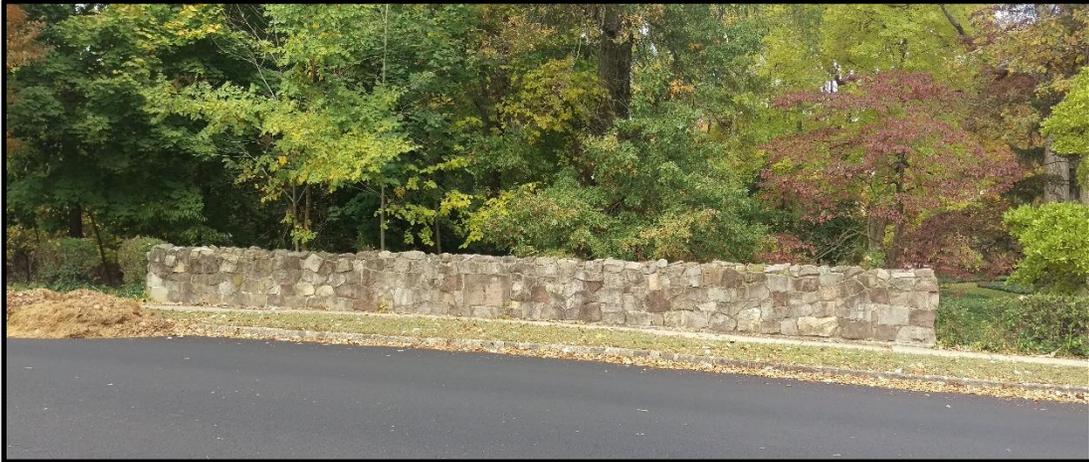
83) Orchard Street Bridge (STR# 2003071), Orchard Street over Rahway River Tributary

Although evaluated as contributing in the Panamerican Report, the culvert was constructed 1979, and is therefore a non-contributing structure within the eligible North Cranford Historic District. No further research or documentation recommended.

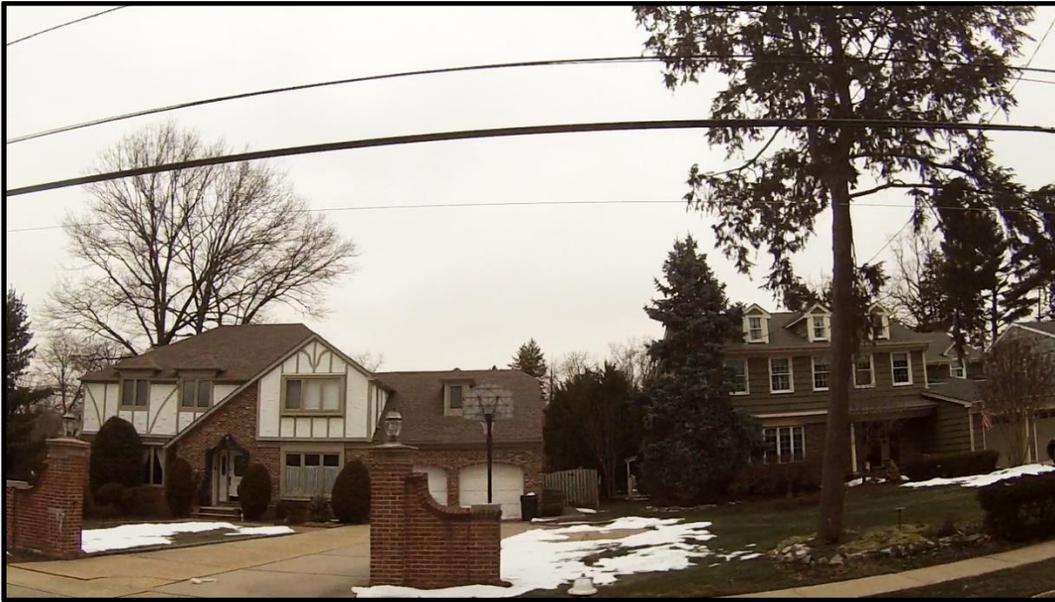
89) Brook Lodge, 410 Orchard Street (Block 171, Lot 1.04)

Brook Lodge was demolished and replaced with several contemporary houses c1982.
Not eligible. No further research or documentation recommended.

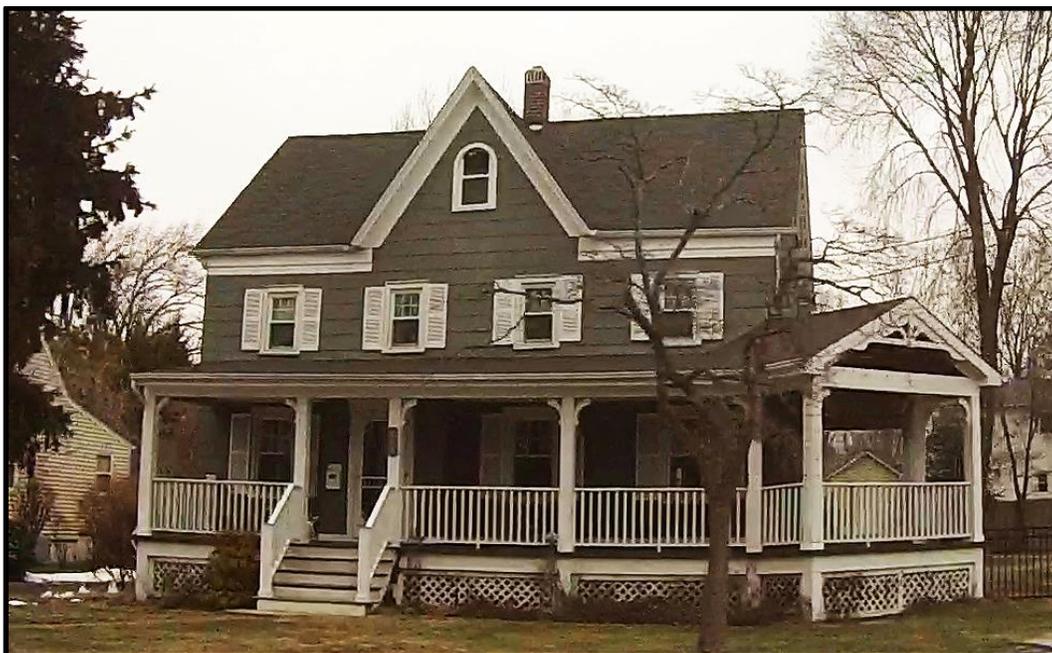
90) Torbush House, 464 Orchard Street (Block 160, Lot 22)

Torbush house was recommended not eligible in the 1984 survey. The building has been altered, and does not appear to have any significant historic associations. The building does not appear to meet the criteria for individual eligibility and is not located in any existing or potential historic district; No further research or documentation recommended.
