**Phase 1 Cranford Historic Resources Survey:
Review of Existing Documentation, Baseline Inventory, and Survey Updates**

Cranford Historic Preservation Advisory Board
Cranford Township, NJ
November 2016

Volume 1: Phase 1 Report

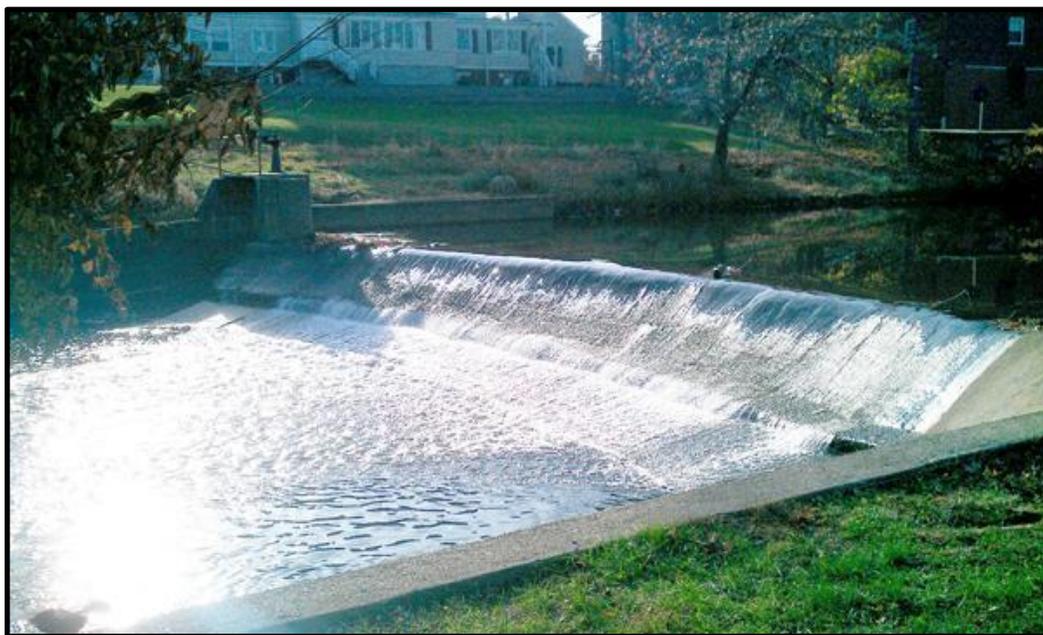
95) Hansel's Dam / Flood Control Dam, Rahway River at N Union Avenue

The dam appears to date from the early 20th century, likely associated with Union County development of the Rahway River Parkway. As such the dam is eligible as a contributing structure within the recommended expanded boundary of the eligible North Cranford Historic District. The dam also contributes to the eligible Rahway River Parkway Historic District and Union County Park System., and will be further evaluated and documented in Phase 2 as part of a comprehensive inventory of resources within the eligible park districts.

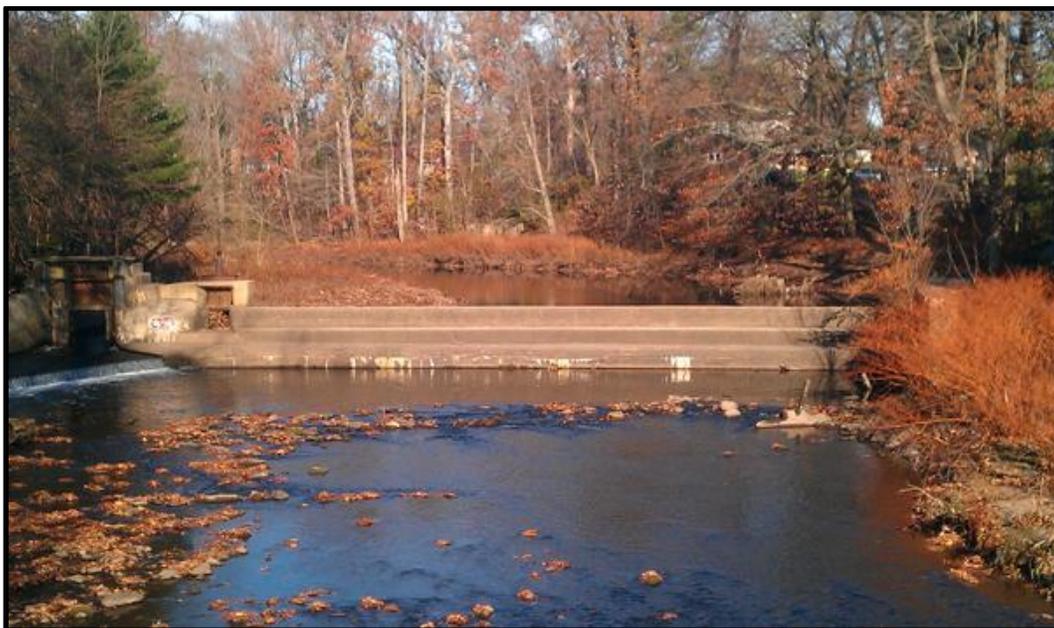
96) Droschers Mill Dam, Rahway River at Lincoln Avenue

Droschers Mill Dam is a concrete spillway spanning the Rahway River just north of Lincoln Avenue East and immediately adjacent to Droschers Mill. The upstream face is a shallow concrete apron and the downstream face is a stepped concrete spillway, with two flood control structures at the west end of the dam. NJDOT discusses the evolution of structures at this location in a 1991 report regarding the Lincoln Avenue-High Street Bridge replacement:

“On April 20, 1893 Crossman Lyon purchased the mill, and subsequently altered both the mill and its landscape. He replaced the waterwheel with a turbine... He also constructed the large cobble/mortar gazebo and other park-like structures that can be found upstream of the mill, as well as completely rebuilt the dam...The turbine was rebuilt c.1910-1919, and c.1923 the dam was rebuilt... The mill dam was reconstructed c. 1923 by Union County.”¹⁴

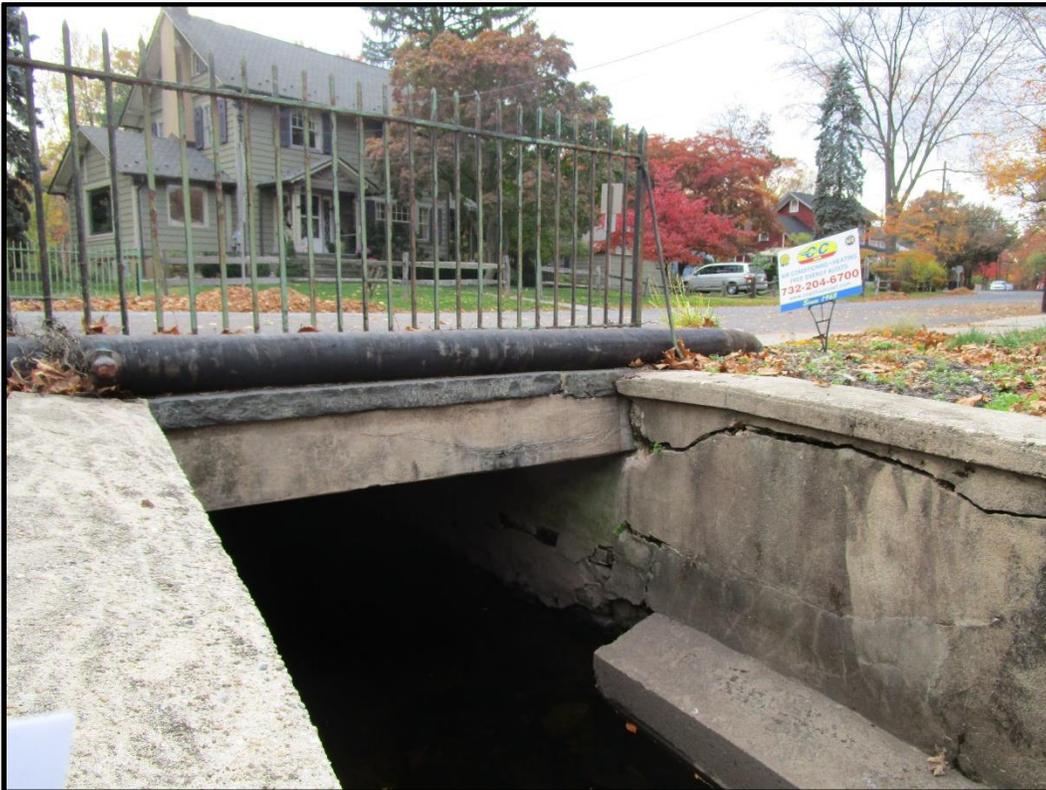
102) Culvert with Metal Railings, Riverside Drive over Casino Brook

The culvert carrying Riverside Drive over Casino Brook is an approximately 6' span concrete box culvert (or concrete slab on concrete abutments) topped with metal railings. The construction date of the culvert is unknown, but appears to date from the early 20th century. As such the culvert is eligible as a contributing structure within the recommended expanded boundary of the eligible North Cranford Historic District. This culvert will be further documented and evaluated at Phase 2. Future flood control work at this location should be designed to minimize impacts to this historic structure.

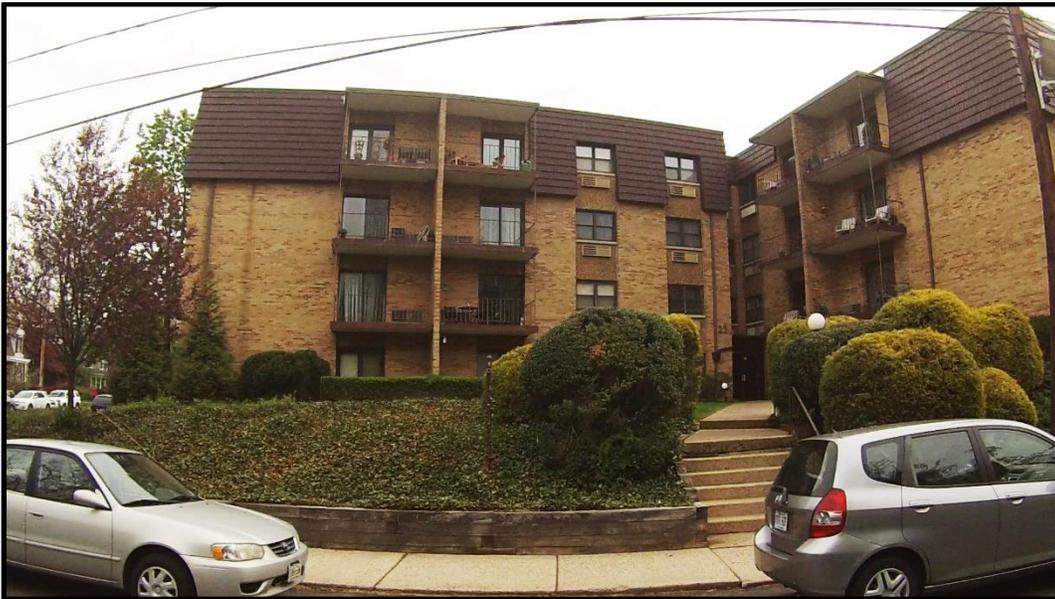
104) Riverside Condominiums, 22 Riverside Drive (Block 265, Lot 1)

This modern condominium complex, constructed c1970, has a faux mansard roof, buff brick walls, and aluminum windows. The complex is less than 50 years old and does not meet the criteria for individual eligibility. The complex is considered a non-contributing property in an expanded eligible North Cranford Historic District. No further research or documentation recommended.

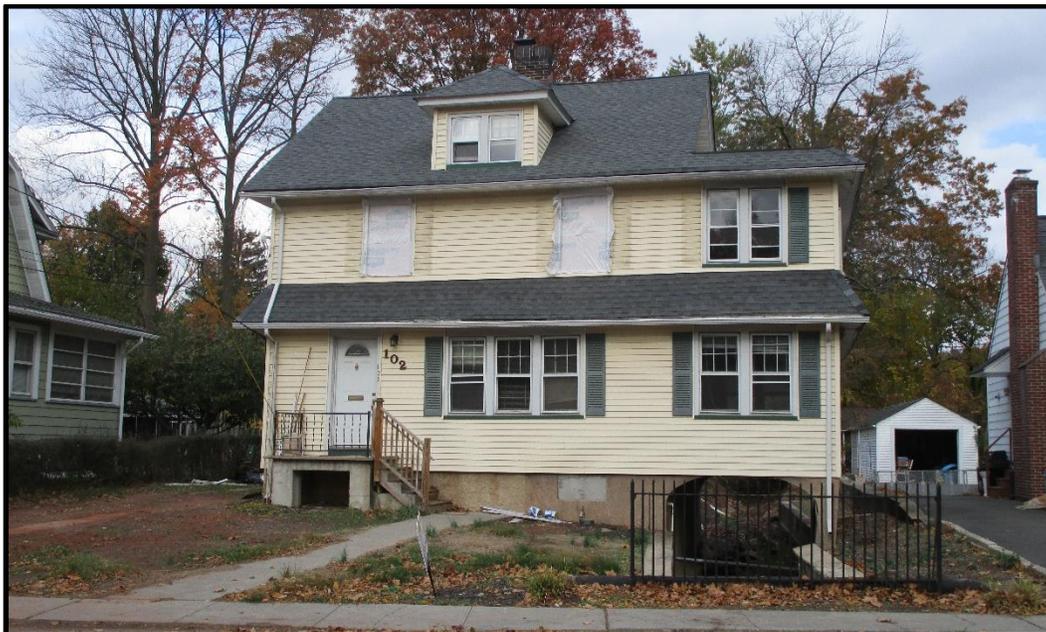
105) 102 Riverside Drive (Block 264, Lot 16)

102 Riverside Drive is a 2 ½ story side gable house with minimal Colonial Revival elements constructed c1929. The house is uniquely sited, with the right bay spanning the Casino Brook, a tributary of the Rahway River. The asphalt shingle roof has a central brick chimney and a hip roof dormer with paired windows centered on the front roof slope. A two-story flat roof section stands on the right with a concrete arched foundation that spans the stream. An asphalt shingled pent roof spans the front and left and right sides above the first floor. The main entrance is on the left, with a replacement door, and modern open concrete portico with wooden steps. Windows are vinyl replacements throughout with inoperable vinyl shutters. Cladding is vinyl siding and the foundation is stuccoed.

102 Riverside Drive is eligible as a contributing building within the recommended expanded boundary of the eligible North Cranford Historic District. Future flood control work at this location should be designed to minimize impacts to this historic building.

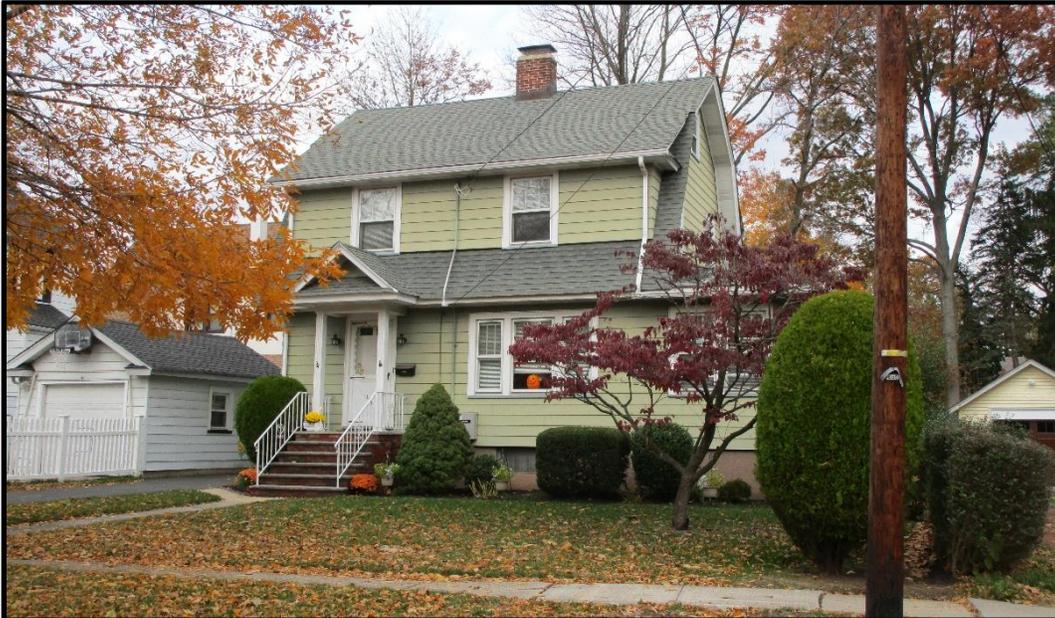
106) 104 Riverside Drive (Block 264, Lot 17)

104 Riverside Drive is a two story Dutch Colonial Revival house with a side-gambrel roof, central brick chimney, and full width shed roof dormer with two windows. A pent roof spans the façade above the first floor, with a projecting gable roof portico above the entrance at the left end. The portico is supported on square columns standing on brick steps with metal railings. A one story hip roof addition stands on the right side. Windows are vinyl replacements and cladding is vinyl. The foundation is stuccoed.

104 Riverside Drive is eligible as a contributing building within the recommended expanded boundary of the eligible North Cranford Historic District.

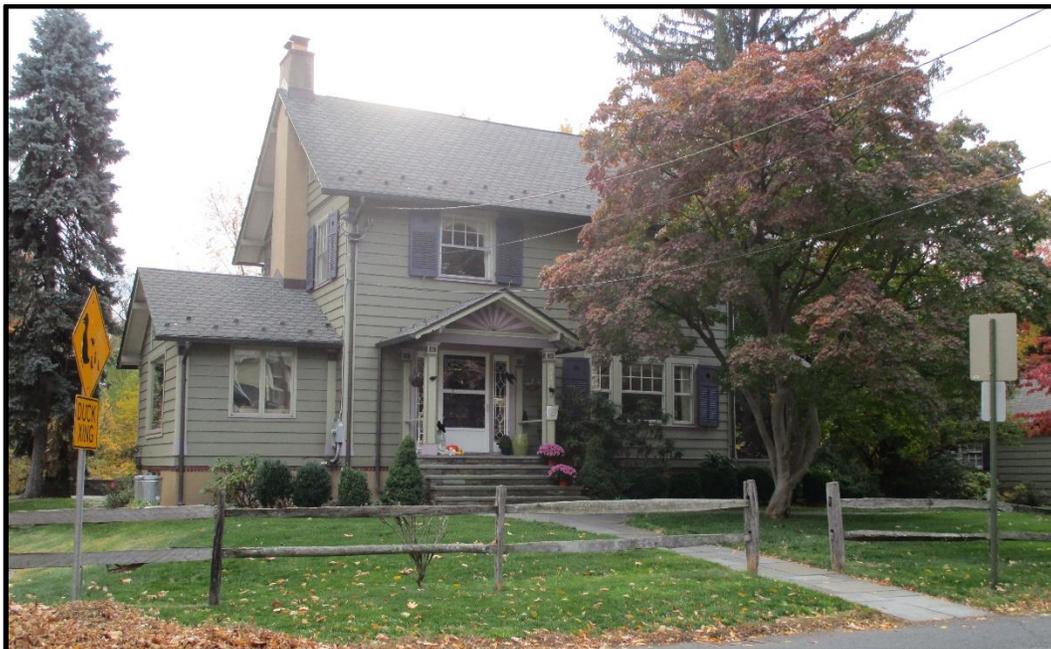
107) 107 Riverside Drive (Block 261, Lot 7)

107 Riverside Drive is a two story side gable house with Craftsman elements constructed c1930 (noted as "from plans" on 1929 Sanborn map.). The asphalt shingle roof has open eaves with wide overhangs and exposed purloins. An exterior chimney stands centered on the left gable end. A one story side gable addition extends from the left gable end, slightly set back from the façade. The main entrance is covered by a gable roof portico with open eaves, sawn vergeboards, and exposed purloins, which is supported on square columns and engaged pilasters. The doorway is flanked by leaded glass sidelights. Modern stone facing has been applied to the steps. Windows are vinyl replacements with operable wooden shutters in the main block, and casements in the addition. Cladding is wood clapboard (or replacement wood product) and foundation is stuccoed.

107 Riverside Drive is eligible as a contributing building within the recommended expanded boundary of the eligible North Cranford Historic District.

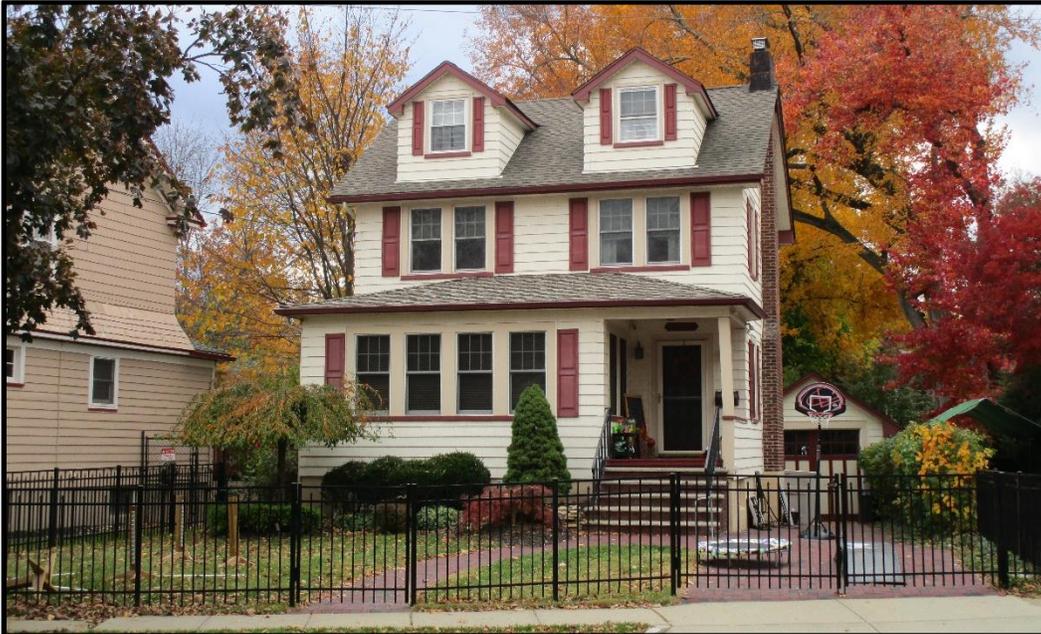
109) 123 Riverside Drive (Block 222, Lot 4)

123 Riverside Drive is a two story side-gable Colonial Revival house with boxed overhanging eaves and two large gable roof dormers on the front roof slope. An exterior brick chimney is centered on the on the right gable end. Rectangular attic windows exist in the upper gables. A hip roof porch spans the façade, the left two thirds of which has been enclosed. Brick steps with metal railings access the entrance under the porch on the right side. Windows are double hung replacements with exterior storm windows and inoperable shutters, and cladding is vinyl siding. The foundation is stuccoed.

123 Riverside Drive is eligible as a contributing building within the eligible North Cranford Historic District.

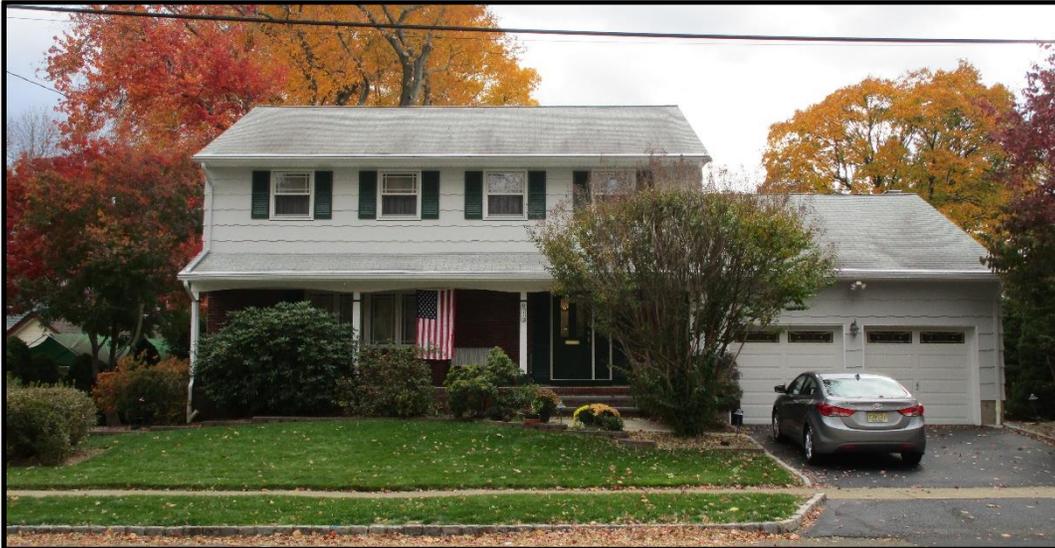
110) 127 Riverside Drive (Block 222, Lot 2)

127 Riverside Drive is a two-story side gable house constructed c1971 with full width shed roof front porch and attached one-story side gable two-car garage at right, forward of the main block. Upper story and garage cladding is composite shingle with uneven bottom edges. Lower façade is clad in brick. The house is less than 50 years old and is non-contributing to the eligible North Cranford Historic District. No further research or documentation recommended.

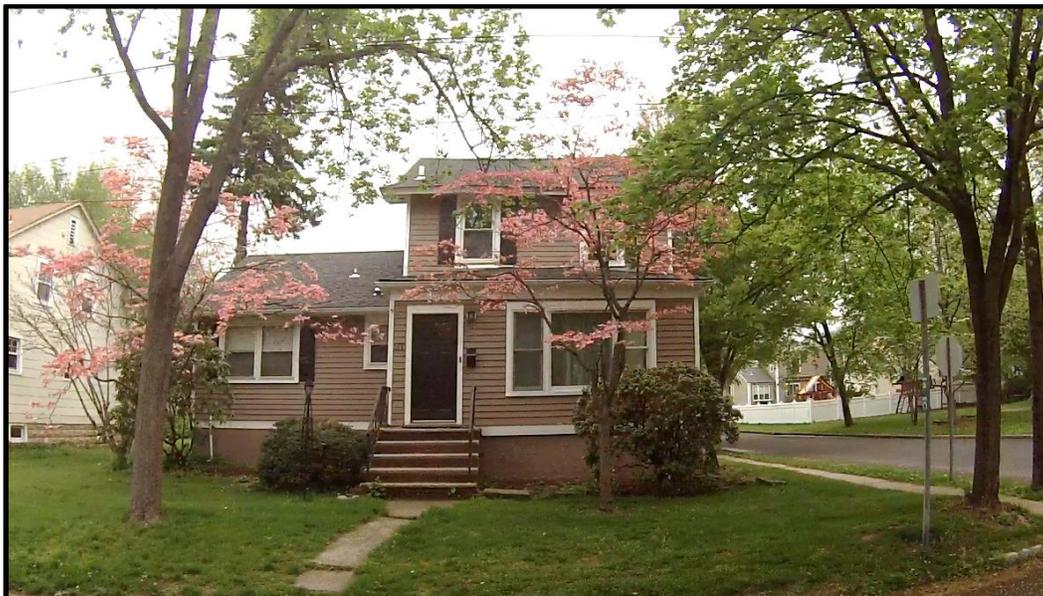
112) 500 Riverside Drive (Block 216, Lot 1)

500 Riverside Drive is a two-story two-bay side-gable house with asphalt shingle roof, overhanging eaves, and a shed roof enclosed front porch on a corner lot. A one story side gable addition extends from the left gable end. Two shallow hip roof bays with triple windows (central double-hung flanked by two narrow double hung) project from the right gable end. Windows are vinyl replacements with inoperable shutters and cladding is vinyl siding. The entrance is at left of the main block, accessed by brick steps with metal railings. Foundation is stuccoed.

This house has been altered over time, and does not appear to have any significant historic associations. The building does not appear to meet the criteria for individual eligibility and, although located across from the Rahway River Parkway, the house is not located in any existing or potential historic district; No further research or documentation recommended.

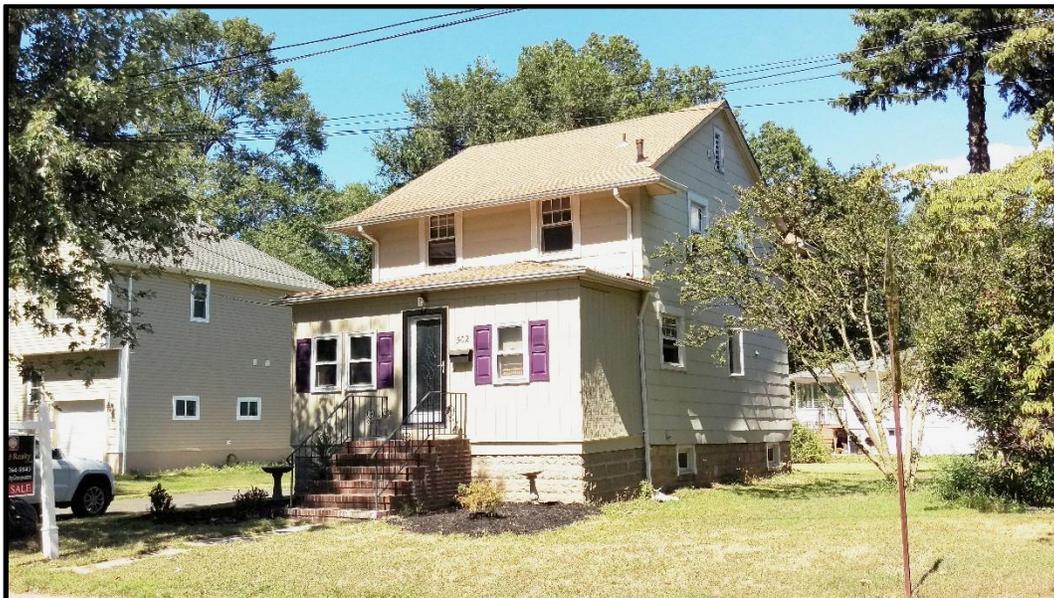
113) 502 Riverside Drive (Block 216, Lot 2)

502 Riverside Drive is a two-story two-bay side-gable house with asphalt shingle roof, overhanging eaves, and a hip roof enclosed front porch. Two shallow hip roof bays with triple windows (central double-hung flanked by two narrow double hung) project from the left gable end. Windows are vinyl replacements, with inoperable shutters on the enclosed porch. Cladding is cementitious shingle on the main house, and vertical grooved plywood on the porch. The entrance is centered and accessed by brick steps with metal railings. Foundation is textured block.

This house has been altered over time, and does not appear to have any significant historic associations. The building does not appear to meet the criteria for individual eligibility and, although located across from the Rahway River Parkway, the house is not located in any existing or potential historic district; No further research is recommended.

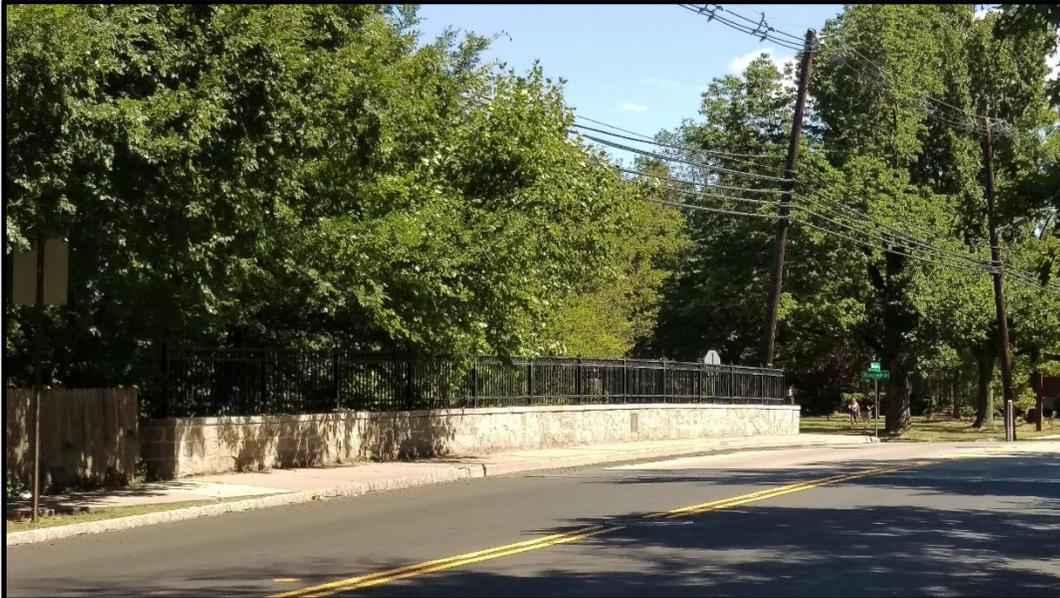
**124) Springfield Avenue Bridge (STR# 2003072), Springfield Avenue over Rahway River
(NW crossing)**

Constructed in 2003, the current Springfield Avenue Bridge over the Rahway River (NW crossing, Structure # 2003072) replaced the former historic 1915 through-plate-girder bridge. The current bridge is a steel deck-girder design with stone faced concrete parapets topped with ornamental metal railings. This is a design similar to numerous other replacement bridges constructed by Union County and NJDOT in Cranford and surrounding areas.

The Springfield Avenue Bridge is a non-contributing structure within the eligible North Cranford Historic District, Rahway River Parkway Historic District, and Union County Park System. The bridge will be included in Phase 2 as part of a comprehensive inventory of resources within the eligible park districts.

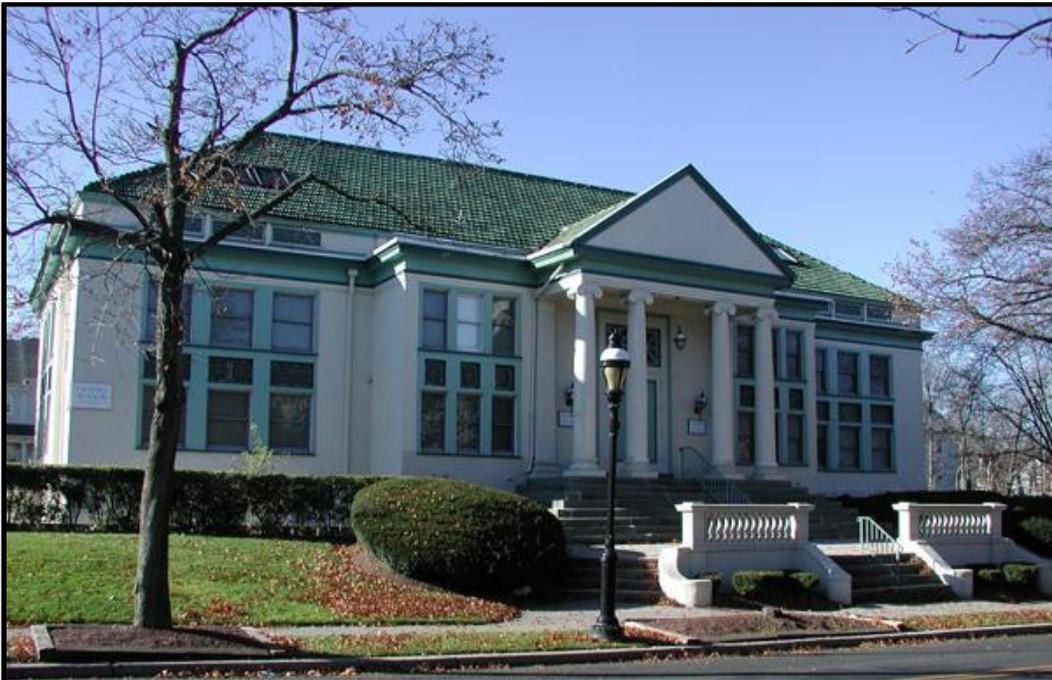
130) First Church of Christ Scientist, 21 Springfield Avenue (Block 188, Lot 11)

The former church is eligible as a contributing building within the recommended expanded boundary of the eligible North Cranford Historic District. Although recommended as individually eligible in both the 1984 and 2001 surveys, it is unclear how the conversion to condominiums (date unknown) has affected the architectural integrity of the interior, which will be further researched and documented in Phase 2 in order to make a determination on individual eligibility.

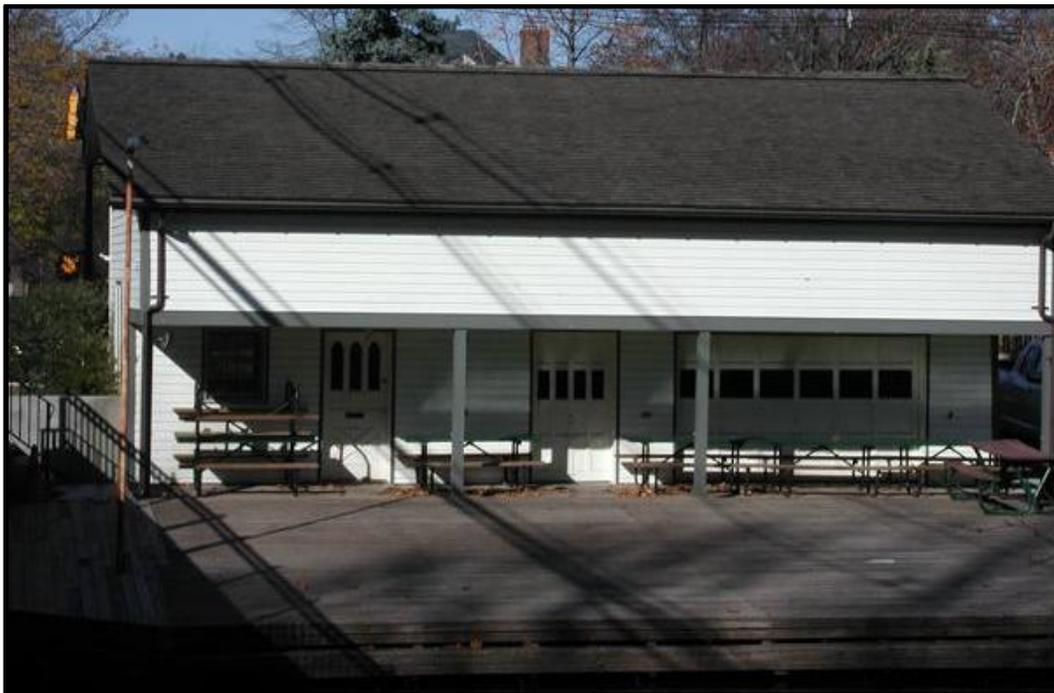
133) Cranford Canoe Club, 250 Springfield Avenue (Block 261, Lot 1)

The Cranford Canoe Club is a simple gable-roof boat house constructed c1910 fronting on the Rahway River at the corner of Springfield Avenue and Orchard Street. An inset porch supported on square posts covers the two entrance doors at left and a modern garage door accessing boat storage at right. Renovations in 2005 replaced the exterior wood clapboard siding and wood window sash. A wood dock extends from the porch to the riverbank providing access for launching canoes and kayaks. Owned by Cranford Township, the building is leased as a canoe rental facility.

The Cranford Canoe Club, originally known as the Ulhigh Canoe Club, is the last of a number of clubs that once existed along the river. It was determined eligible as a contributing resource to the North Cranford Historic District in a 5/19/2005 NJ SHPO Certification of Eligibility. The Canoe Club also contributes to the eligible Rahway River Parkway Historic District and Union County Park System, and will be included at Phase 2 as part of a comprehensive inventory of the eligible park districts.

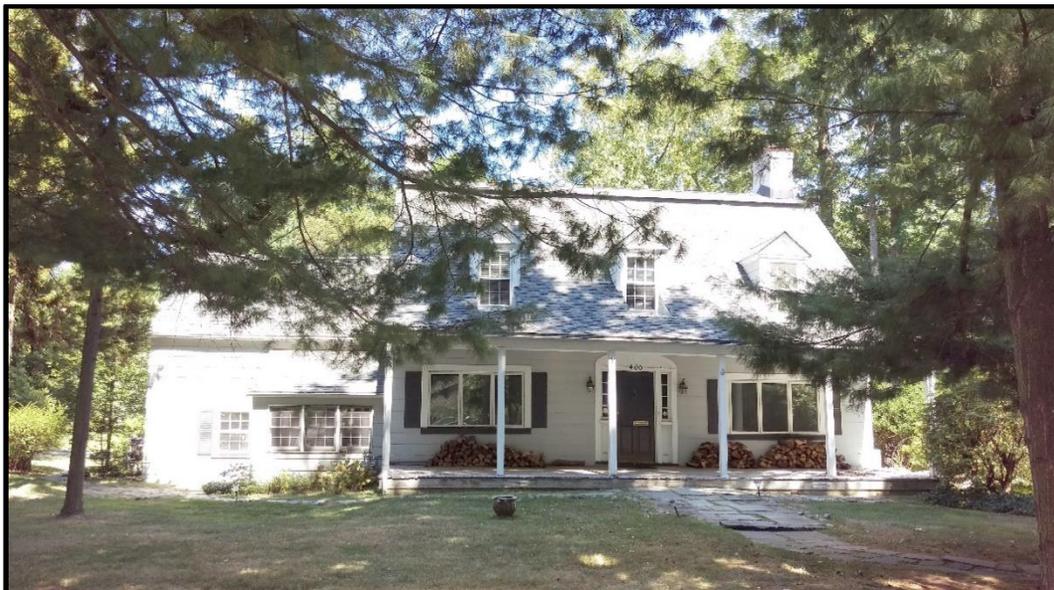
140) Dykeman Farmhouse, 400 Springfield Avenue (Block 200, Lot 48)

The Dykeman Farmhouse is a 1½-story 3-bay side gambrel Dutch Colonial Revival style house constructed c1929. The multi-pitched front roof slope creates an inset porch. Three gabled dormers with six-over-six double hung sash are slightly recessed into the front slope. Interior brick chimneys centered on the ridgeline at each gambrel end. The porch is supported on square wood posts. Replacement triple casement windows with inoperable shutters are located on either side of the central doorway, which has sidelights and a blind segmentally arched fanlight with sunburst molding. A one story gable roof extension is attached to the left gambrel end, with a smaller shed roof addition attached at front left. Exterior is clapboard, except for the lower half of the gable end wall of the extension which is random laid stone.

The Dykeman Farm House is eligible as a contributing building within the eligible North Cranford Historic District. Additionally, this house was described in the 1981 Union County Survey as a replica of the 18th Century Dyckman Farmhouse in New York City (HABS documented; note the correct spelling), however no direct attribution for this is provided. Further research into this association will be documented in Phase 2, and the potential for additional significance related to Colonial Revival replication will be further evaluated.

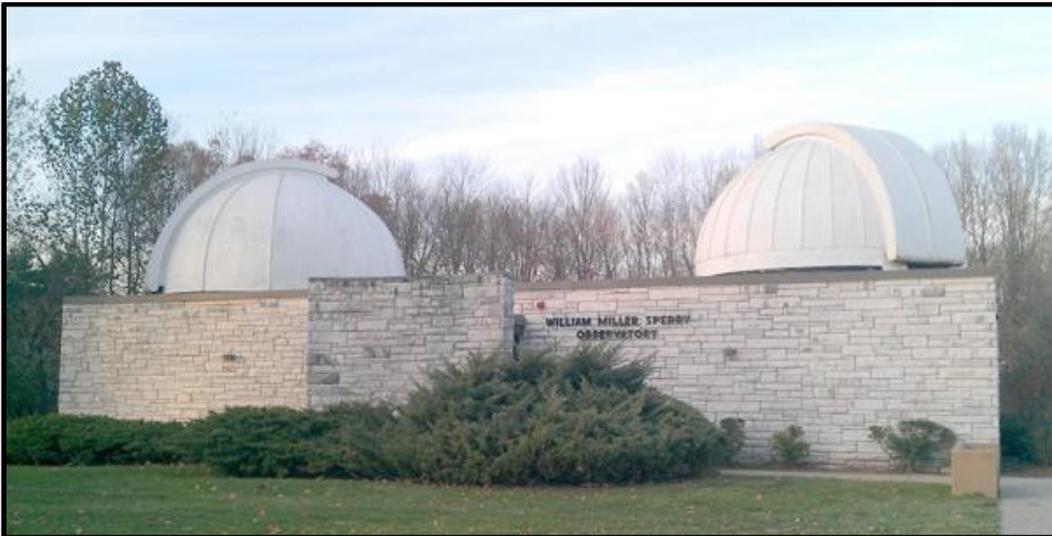
142) William Miller Sperry Observatory, 1033 Springfield Avenue (Block 121, Lot 2.01)

The William Miller Sperry Observatory is an astronomical observatory on the campus of Union County College. The Modern style building has a flat roof with two observation domes. Walls are clad in random coursed marble veneer. The aluminum and glass entrance is hidden behind a convex curved projecting wall clad in the same marble veneer. Small aluminum light fixtures are located on either side of the entrance, and metal letters applied to the upper facade right of the entrance indicate the name of the facility. Mature evergreen foundation plantings have grown in around the entryway and along the left side. A similarly designed sculptural sundial stands to the right of the building.

Completed in 1967 through a donation from Mrs. Frederick Beinecke and William Beinecke, the iconic building is unique, and one of only seven operating public observatories in New Jersey. It was cited as only the 2nd observatory in NJ on a college campus, and the first in the nation at a two-year college. The sundial was constructed 1972 through a donation from the Kiwanis Club of Cranford, but is in poor condition and in need of conservation.

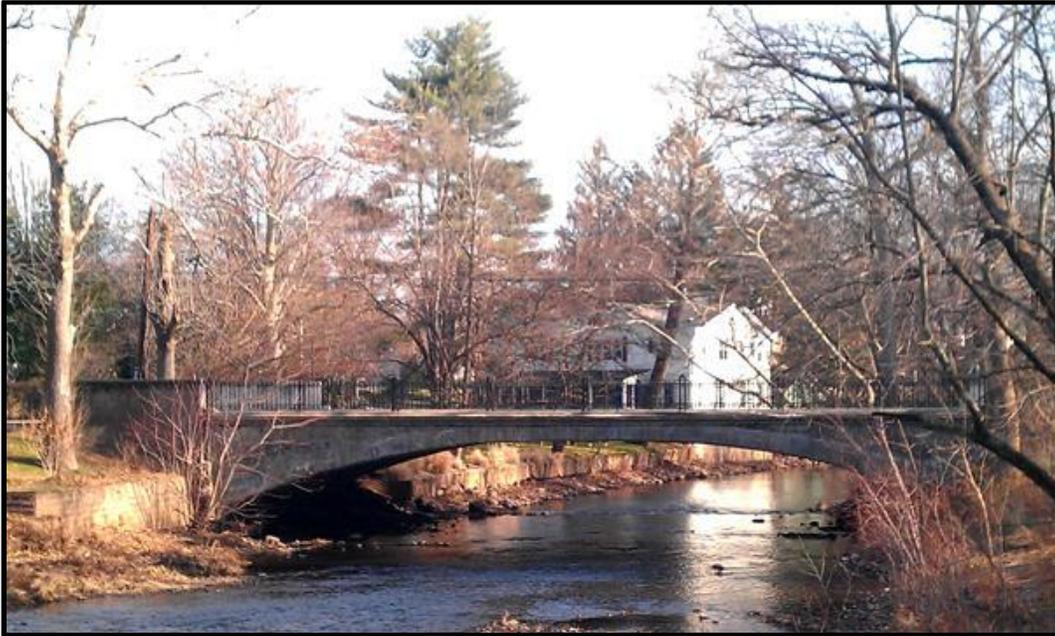
143) North Union Avenue Bridge (STR# 2003016), North Union Ave. over Rahway River

The bridge is eligible as a contributing structure in the recommended expanded boundary of the eligible North Cranford Historic District. The bridge is also contributing to the eligible Rahway River Parkway Historic District and Union County Park System. The bridge will be included at Phase 2 with a comprehensive inventory of the eligible park districts.

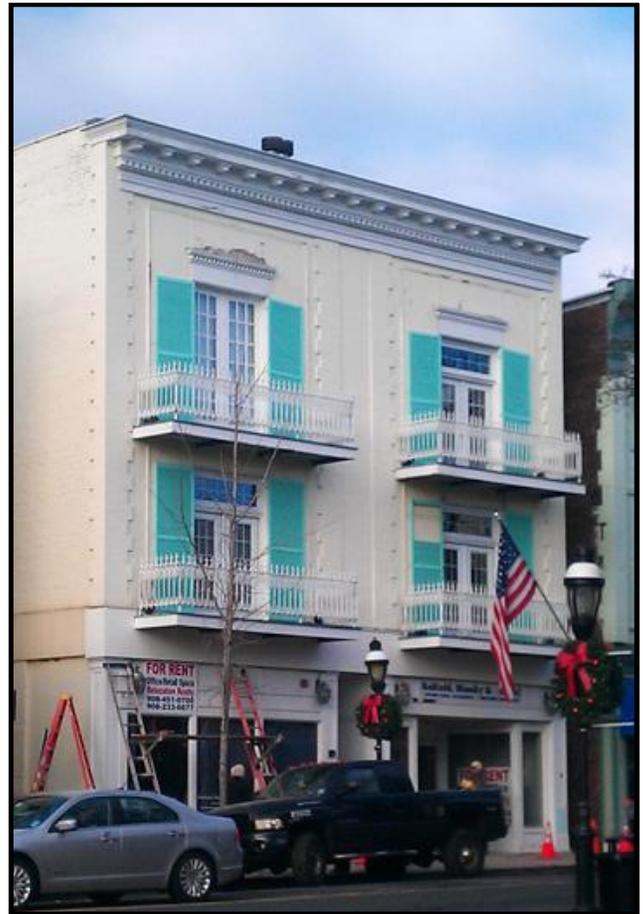
The Smith Building is a three-story brick commercial building in the center of downtown Cranford constructed c1908. The flat roof has a heavy molded cornice with modillion blocks and dentil molding. Brick quoins run up the corners and between the upper story window bays. The ground floor is divided into two retail spaces, with residential apartments above. The building has been significantly altered since it was surveyed in 1981. Two shallow projecting bays of windows spanning the second and third floors were removed and replaced with French doors with oversized inoperable shutters, opening onto shallow metal balconies. Brickwork has been painted. An accounting firm occupies the left side storefront and the right side storefront is currently vacant. Both have wooden framed and plate glass storefronts, date unknown, but providing a traditional appearance.

The building has been extensively altered, and does not appear to have any significant historic associations. The building does not appear to meet the criteria for individual eligibility and is not located in any existing or potential historic district; No further research or documentation recommended.

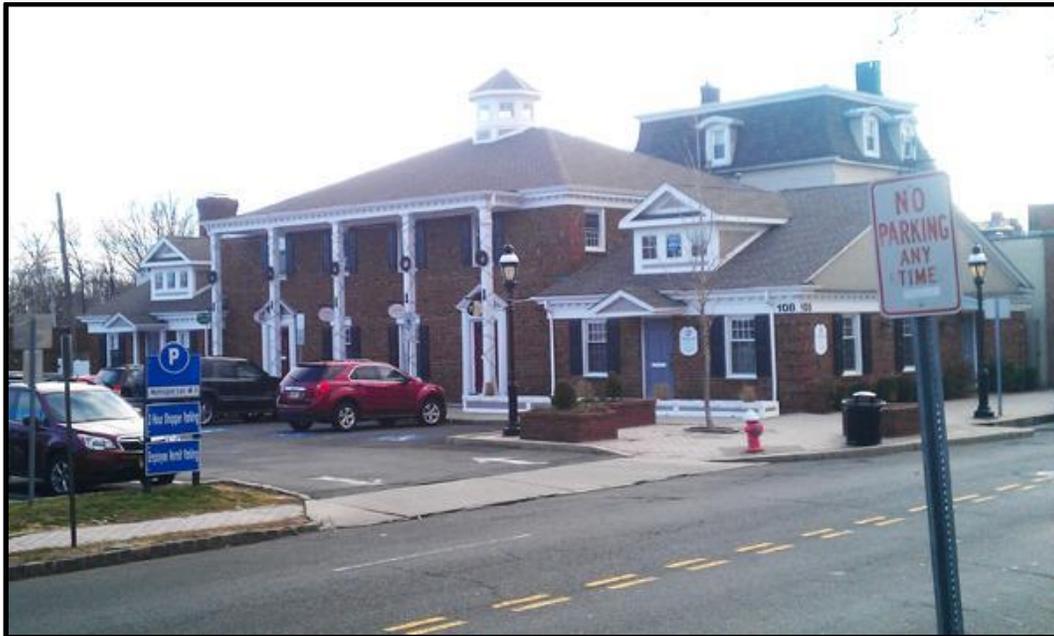
147) Manager Building, 108 N Union Avenue (Block 193, Lot 5)

The Manager Building is a two-story hipped roof brick commercial building with two story portico, and octagonal cupola centered on the ridgeline. Matching 1½-story side gable wings are attached left and right. Constructed c1968, this building is less than 50 years of age. Not eligible. No further research or documentation recommended.

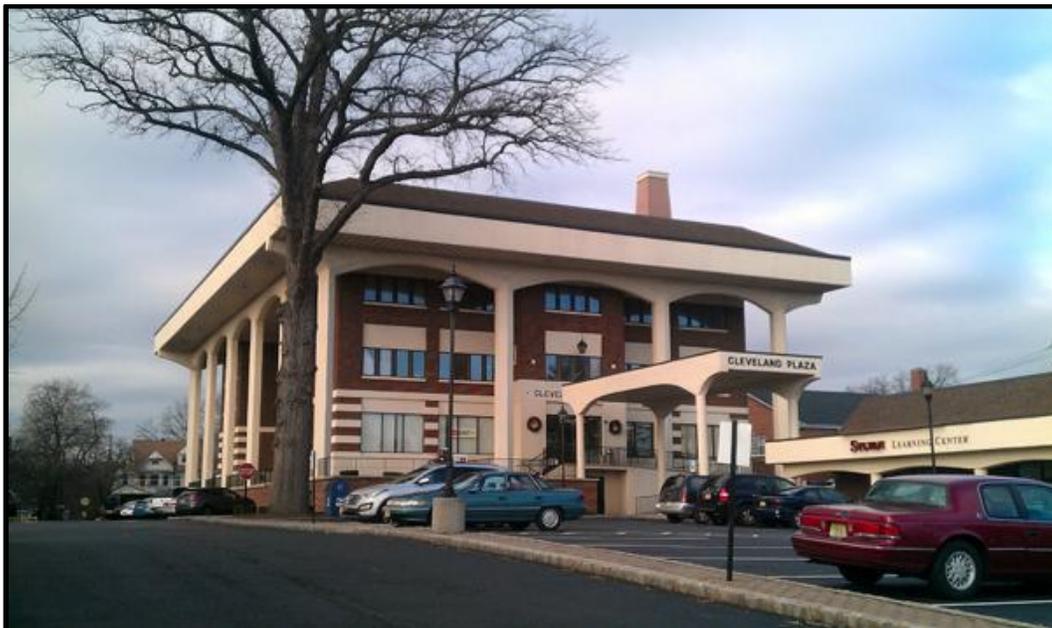
149) Cleveland Plaza, 123 N Union Avenue (Block 191, Lot 2)

The school ceased operation in 1974, and was sold to developers Seltzer and Vizzoni in 1980.¹⁹ The modifications to the property were completed in 1981. Although Cleveland Plaza is one of three surviving early schools in Cranford (others are Cranford High and Lincoln School), due to the extensive alterations the building does not appear to meet the criteria for individual eligibility and is not located within any existing or potential historic district. No further research or documentation recommended.

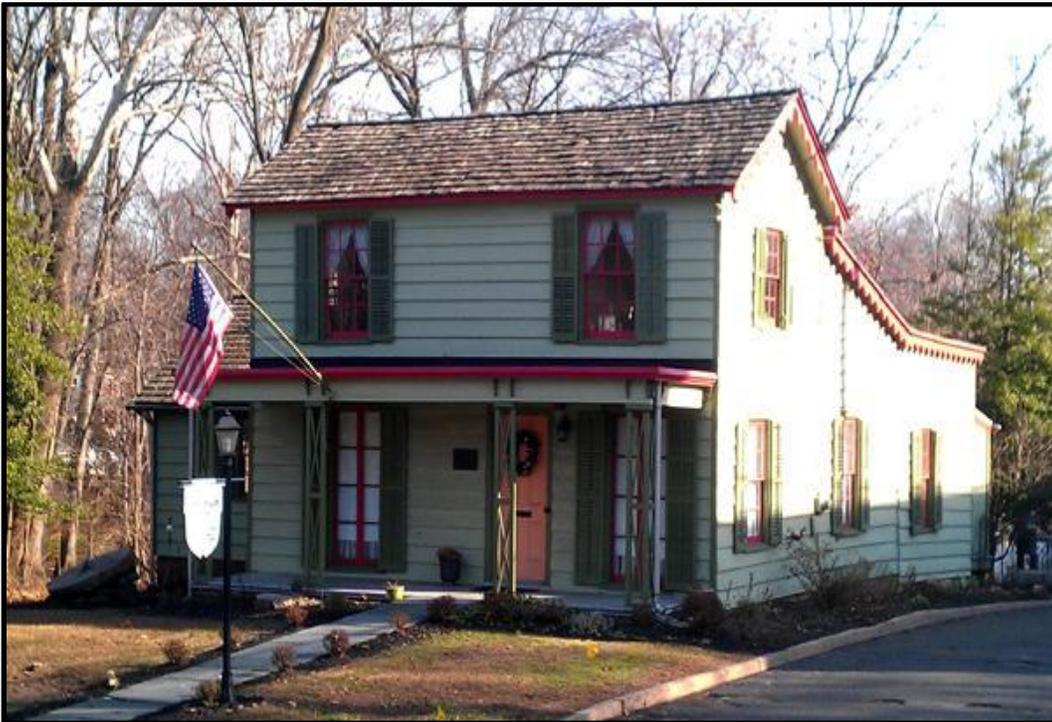
150) Crane-Phillips House, 124 N Union Avenue (Block 96, Lot 2.01)

"Crane-Phillips House is a small two story, frame, Downingsque style rural cottage with an "L" shape floor plan... The front two-story section has a gable roof with hand split cedar shake shingles and the rear one-story section has a nearly flat shed type roof of a composition material. The foundation is a mixture of field stone and brick and the exterior walls are wide clapboard."

National Registers of Historic Places in 1997, and designated as a Cranford Landmark in 2014 (Ordinance #2014-01). As such, no further research or documentation recommended.

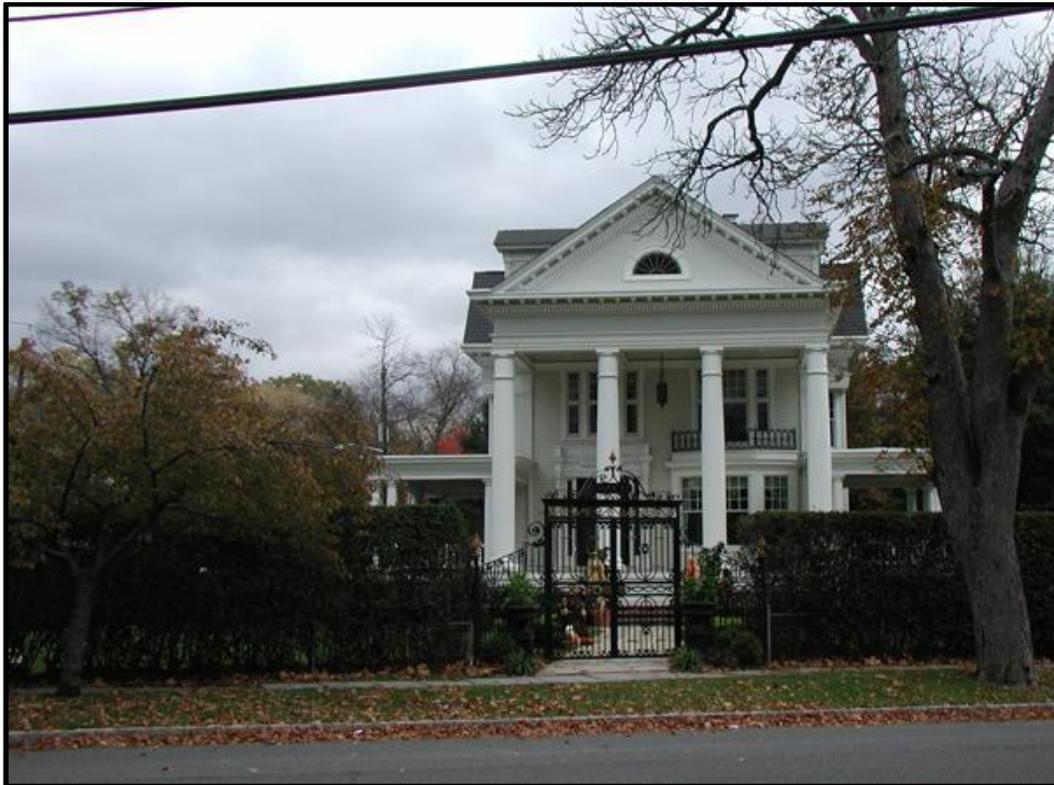
151) Lynwold, 136 N Union Avenue (Block 312, Lot 1)

UCCHPAB-1984: Eligible

Lynwold is individually eligible under Criterion C as an intact and well preserved example of Neoclassical residential architecture, which is among the few surviving examples of late 19th century classicism in Cranford. The house is also eligible as a key-contributing building in the recommended expanded boundary of the eligible North Cranford Historic District.

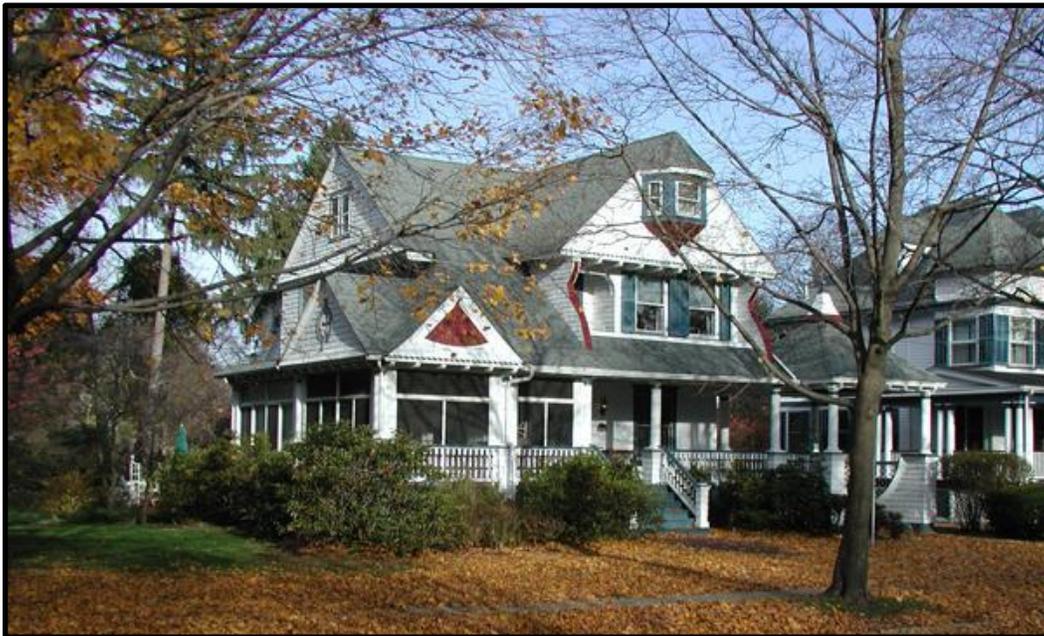
152) Sperry House, 319 N Union Avenue (Block 271, Lot 10)

The Sperry House is individually eligible under Criterion B for its association with Thomas Sperry, co-founder of S&H Green Stamps, who was an active local civic leader and real-estate promoter in Cranford, and under Criterion C as an intact and well preserved example of Queen Anne residential architecture. The house is also eligible as a key-contributing building in the recommended expanded boundary of the eligible North Cranford Historic District

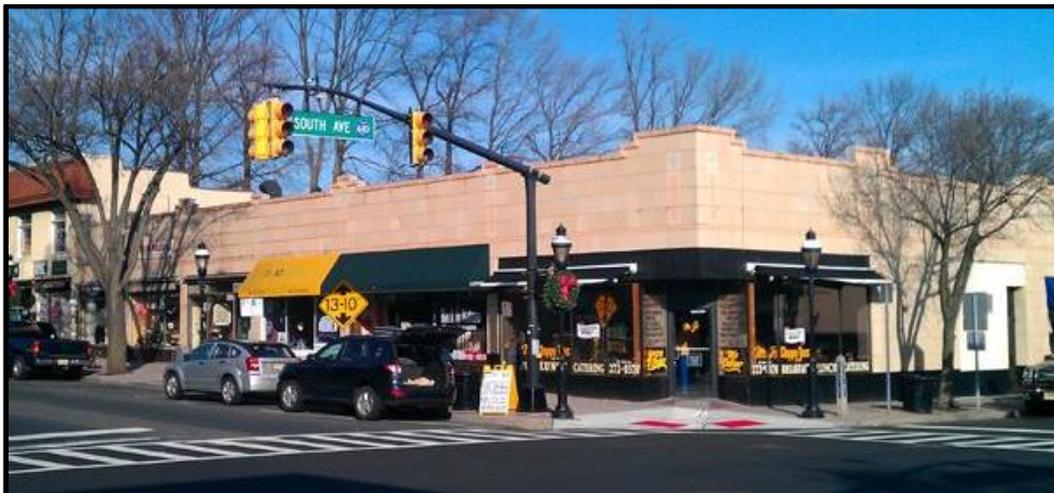
154) 1-15 Walnut Avenue (Block 479, Lot 1)

While the buildings do retain some architectural character in spite of alterations to the storefronts, neither is a particularly strong example of early twentieth century commercial architecture. Nor do they appear to have any significant historic associations. The property does not meet the criteria for individual eligibility and is not located in any existing or potential historic district. Although located adjacent to the Central Railroad of New Jersey Historic District, these buildings do not relate directly to the significance of that district. No further research or documentation recommended.

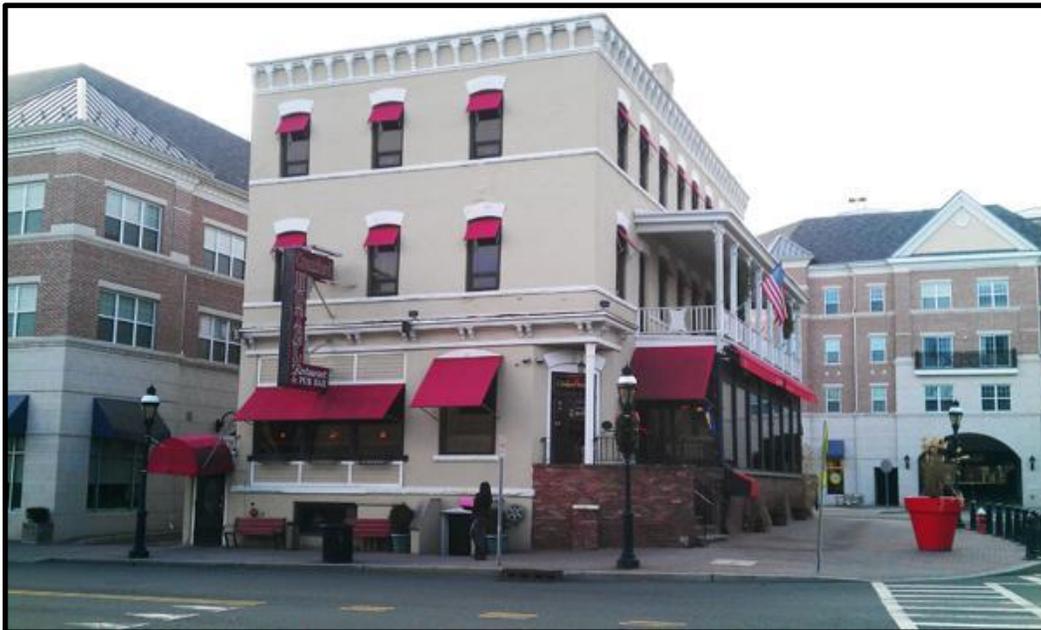
155) Cranford Hotel, 2 Walnut Avenue (Block 476, Lot 1)

The Cranford Hotel is a three-story Italianate style commercial building constructed 1893 immediately adjacent to the Central Railroad of NJ at the corner of N. Union and Walnut Avenues. The flat roof has a brick corbeled cornice on three sides. Rusticated stone belt-courses separate the 2nd and 3rd floors, and serve as stone sills for the windows, which have brick segmentally arched lintels. All upper level windows are modern metal replacements with fixed upper sash and operable hopper lower sash. A wood cornice with paired brackets spans the Walnut St. façade above the 1st floor. A two story porch with flat roof spans the N. Union façade. The lower level has been enclosed with modern fixed plate-glass windows, but the upper level retains a wooden balustrade and square wooden posts with simple square wood capitals. The primary entrance is angled at the northeast corner of the building behind a metal post with simple Corinthian capital supporting the corner of the building. The doorway has a segmental brick-arch lintel and modern glazed door, and is accessed by more recent brick steps with metal railings. A second entrance on Walnut Avenue at the southeast corner provides access to a basement bar and dining room. Modern canvas awnings have been installed over all windows and doors. A large retractable awning extends from the enclosed porch over an outside dining area along N. Union Avenue created through expansion of the sidewalk along the north side of the building. A one story flat roof kitchen addition extends from the west façade.

used as office and storage space. The first floor has been altered to accommodate a large bar and dining rooms on the porch and in the former lobby. As constructed the first floor was slightly above grade level, but the railroad grade separation project by the Central Railroad in 1929 caused the grade to be lowered in the area immediately around the former railroad crossing, which changed the relationship between the hotel and the street to the current configuration.
