**Phase 1 Cranford Historic Resources Survey:
Review of Existing Documentation, Baseline Inventory, and Survey Updates**

Cranford Historic Preservation Advisory Board
Cranford Township, NJ
November 2016

Volume 1: Phase 1 Report

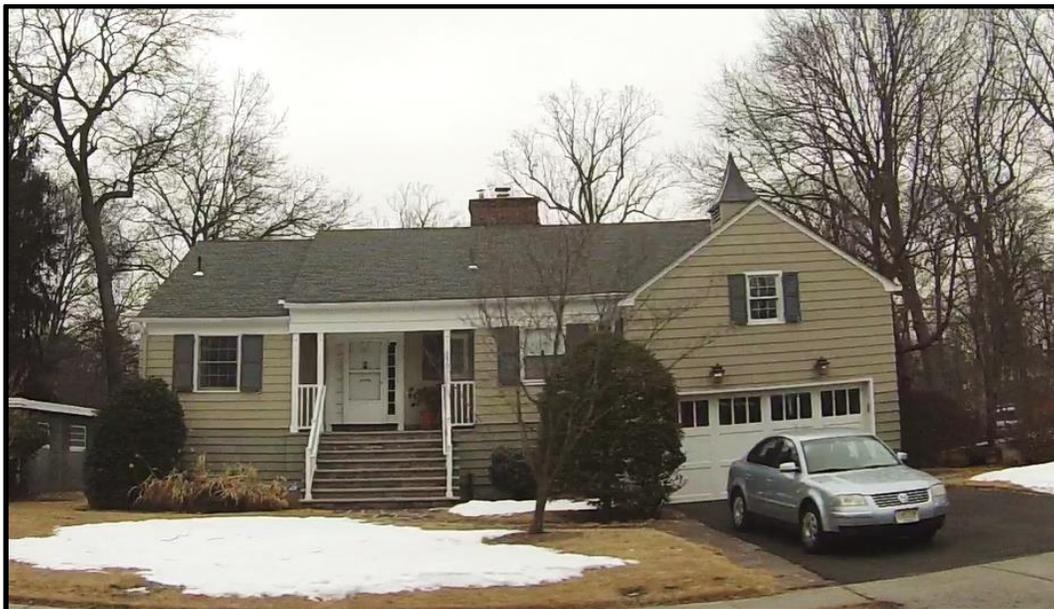
158) 110 Orchard Street (Block 179, Lot 8)

110 Orchard Street is a one-story 5-bay gable-ell bungalow constructed c1949. The side gable main block has a central chimney on the rear slope and a one story extension from the left gable end. A small hip roof cupola stands at the ridgeline of the gable front extension. An inset porch with turned posts contains the main entrance, which has sidelights and a replacement door with exterior storm. Windows are vinyl replacements with inoperable shutters. A large garage door exists in the gable front ell. This house was significantly damaged by flooding from Hurricane Irene in 2011, and was recently elevated to protect against future flooding. The first floor was previously only 1' above grade, and the elevation has added approximately 4' of new foundation.

Due to its date of construction, 110 Orchard Street is a non-contributing building in the eligible North Cranford Historic District.

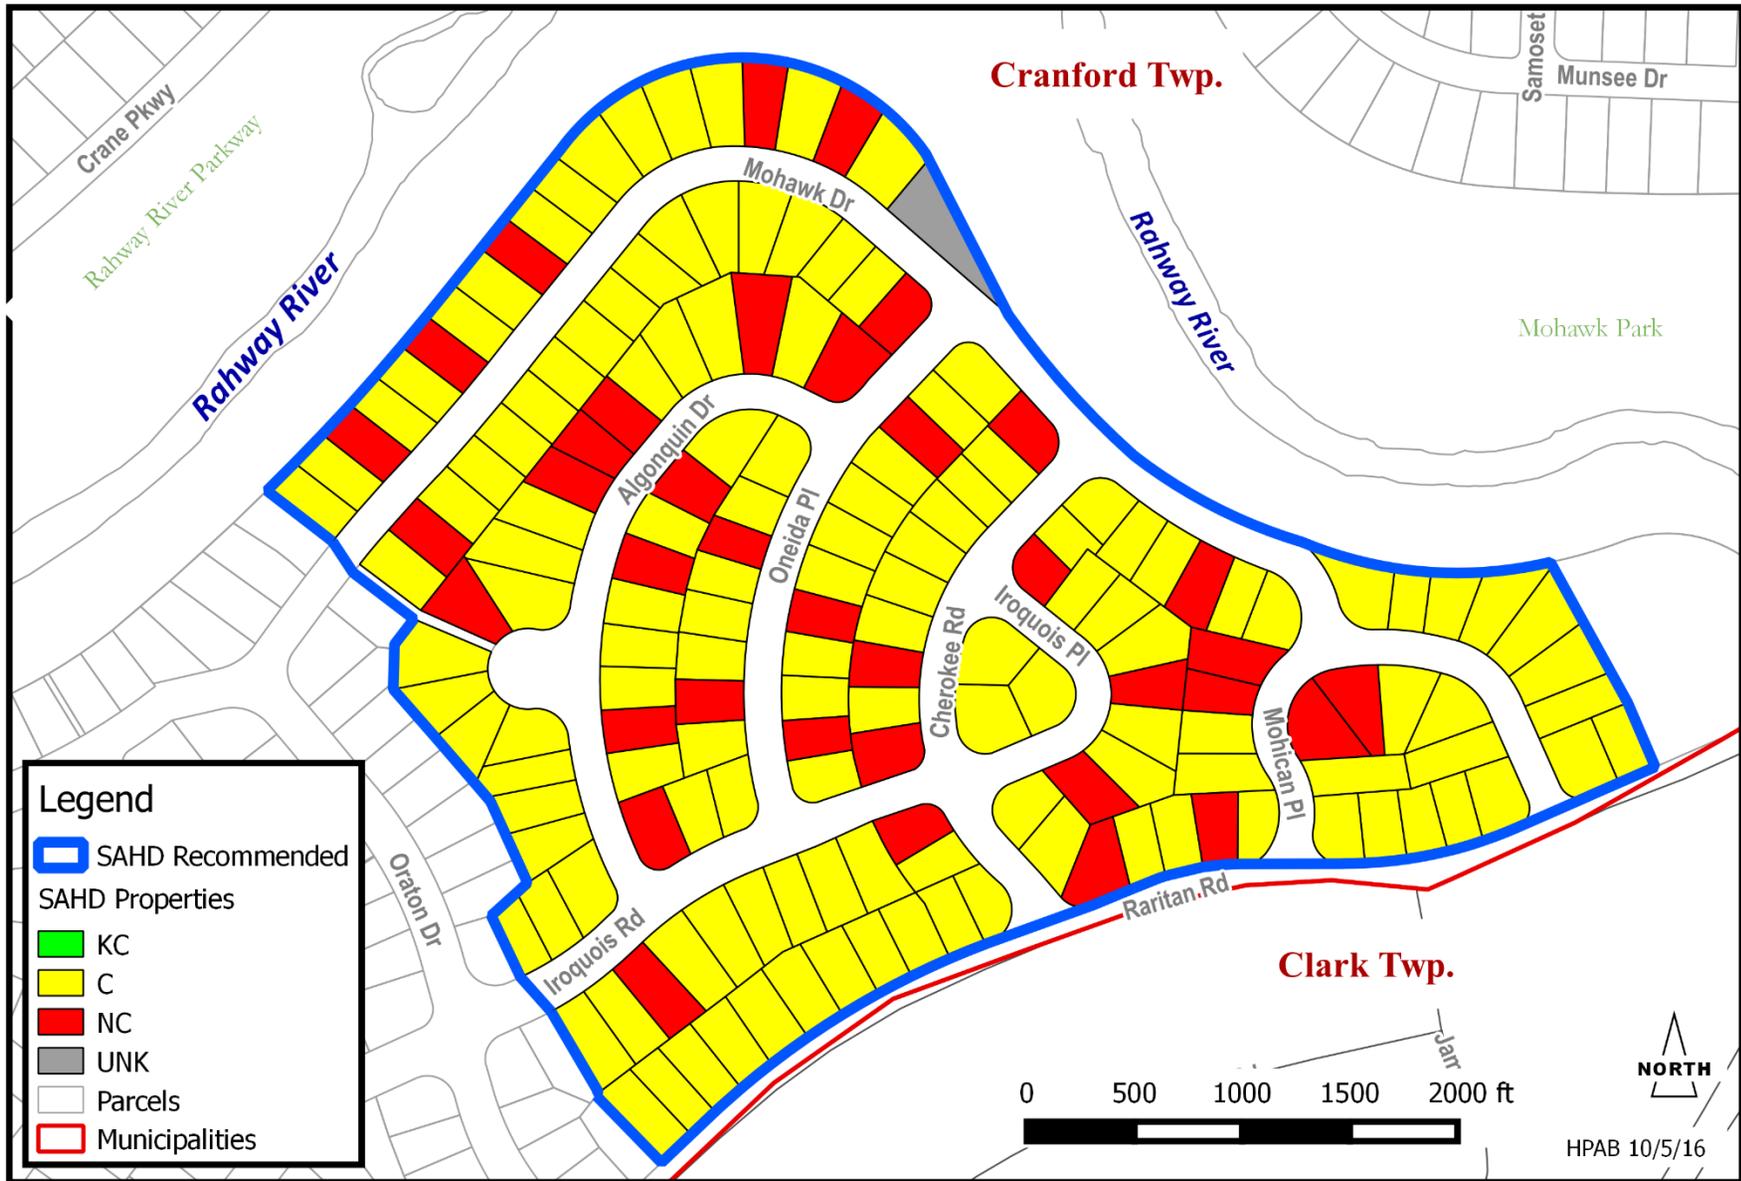
Fig. 27: SAHD Recommended Boundary, 2016

- SW, W, and SW along the front property lines of properties fronting on the NW side of Raritan Road, across Mohawk Drive and Cherokee Road, to the place of beginning.
